ACM and LBP Survey Data and Reports

Limited Asbestos Inspection

Project Site: Unit C102 - Single Family Dwelling
Falcon Village, Texas 78545

LCA Project No.: 130602

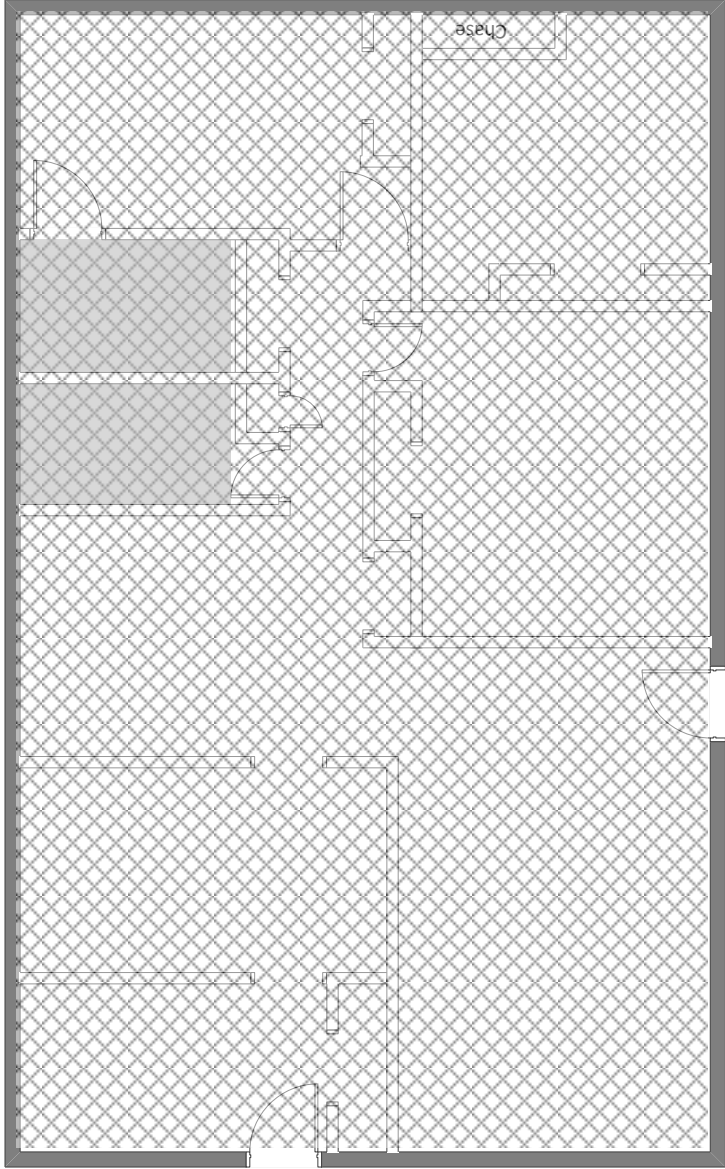
ACM Exterior Stucco

ACM vinyl flooring and black mastic

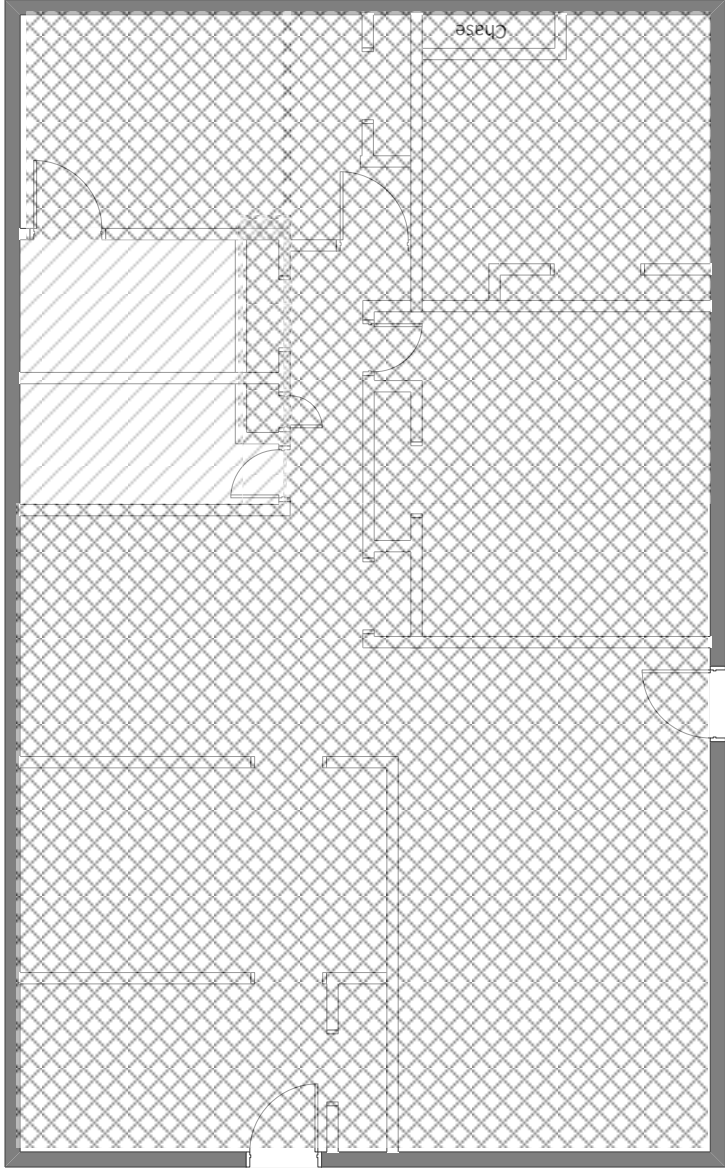
ACM Exterior Stucco

ACM text./joint comp. associated with
gyp-brd walls and ceilings

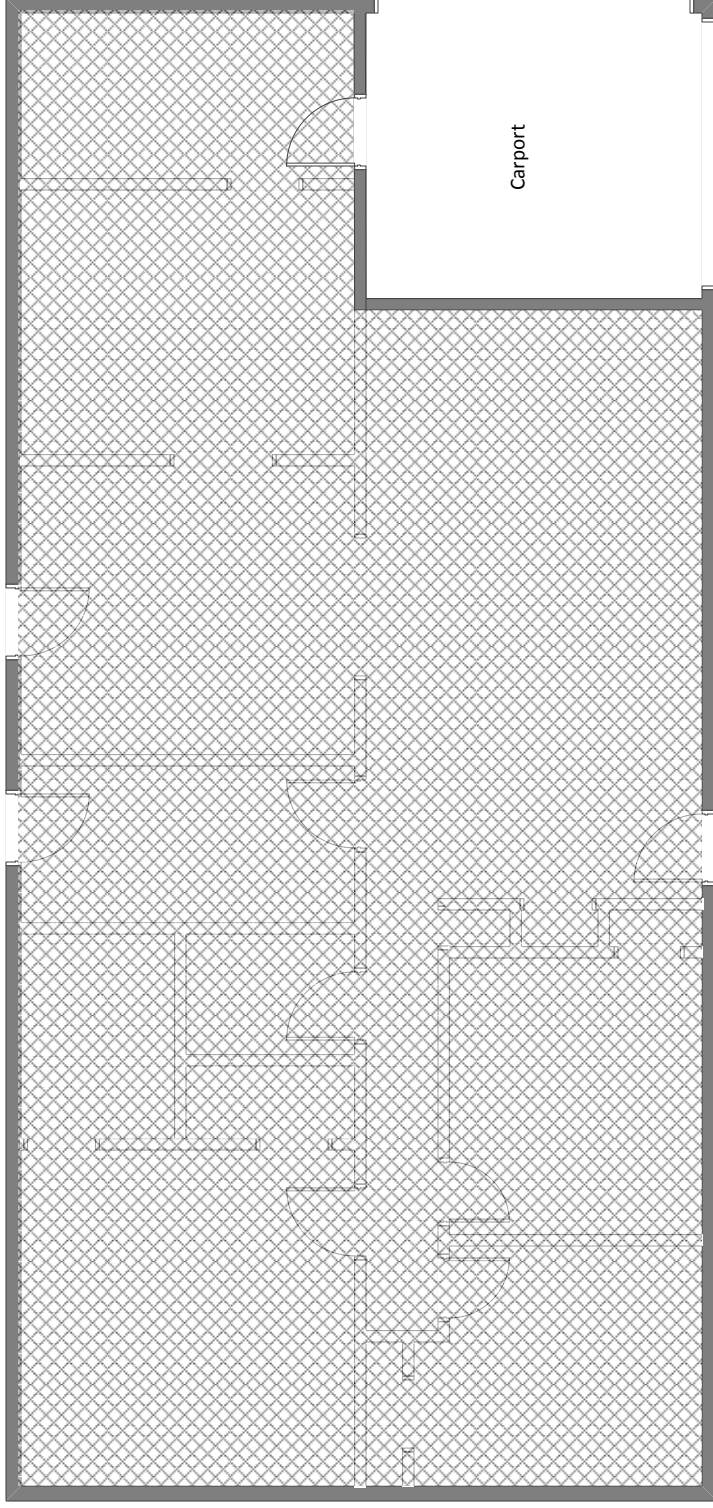
ACM Exterior Stucco

ACM black flooring mastic

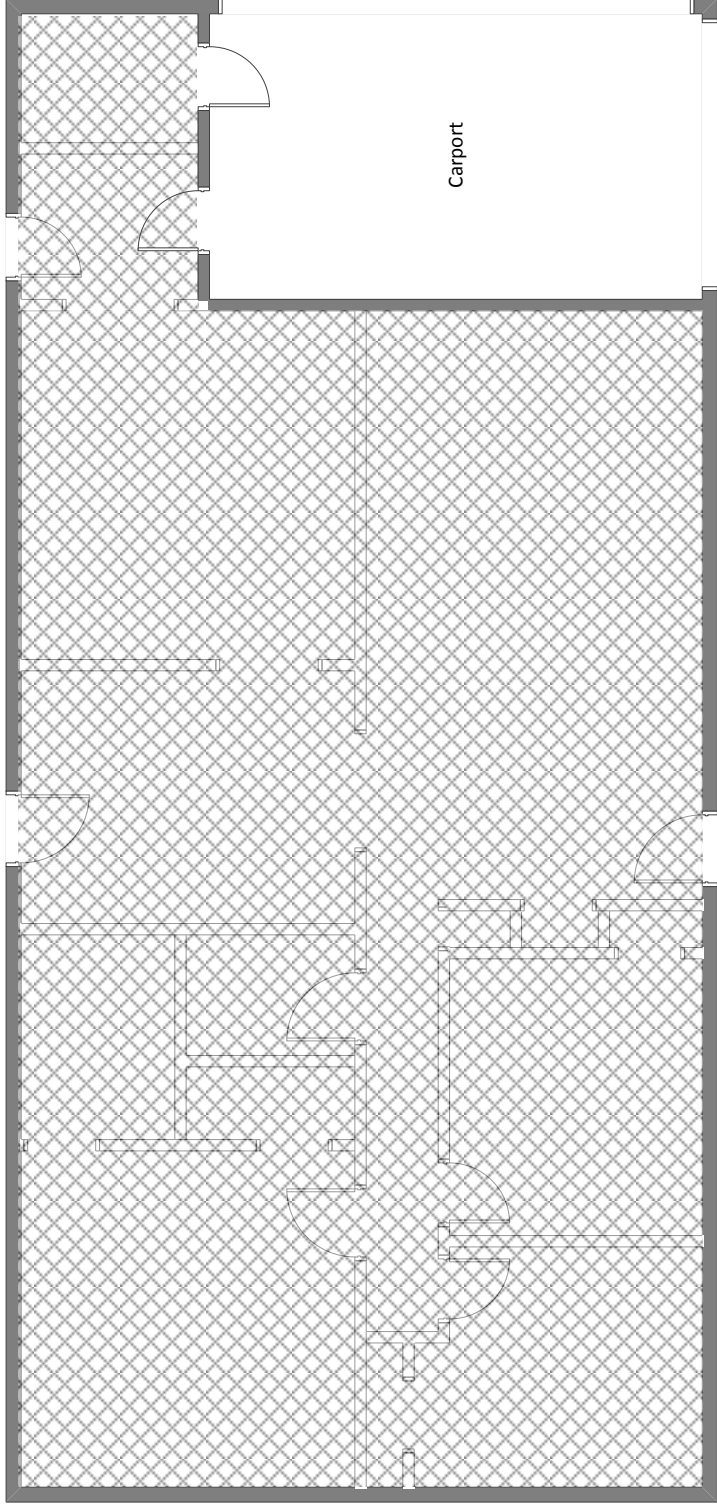
| | | NOT TO SCALE | Quanternary Resource Investigations, LLC NESHAP Compliance Asbestos Survey CBP-Owned Housing, Falcon Village, Texas | Figure 2 Unit 1405 ACBM Location Plan | |

- ACM Exterior Stucco
- ACM vinyl flooring and black mastic
(ACM mastic under ceramic tile in bathrooms)
- ACM text./joint comp. associated with
gyp-brd walls and ceilings

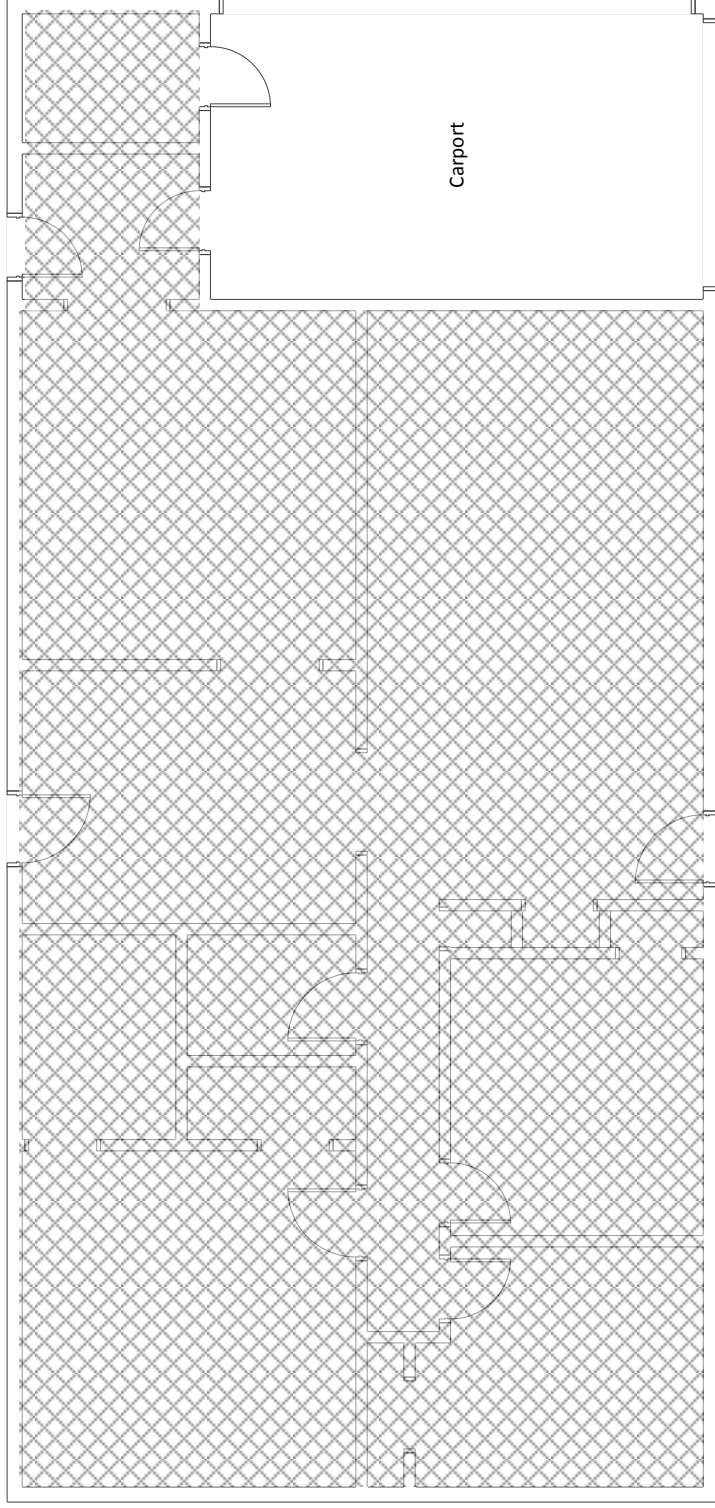
ACM text./joint comp. associated with
gyp-brd walls and ceilings

ACM floor tile and black mastic under sheet flooring
(under ceramic tile in bathrooms)

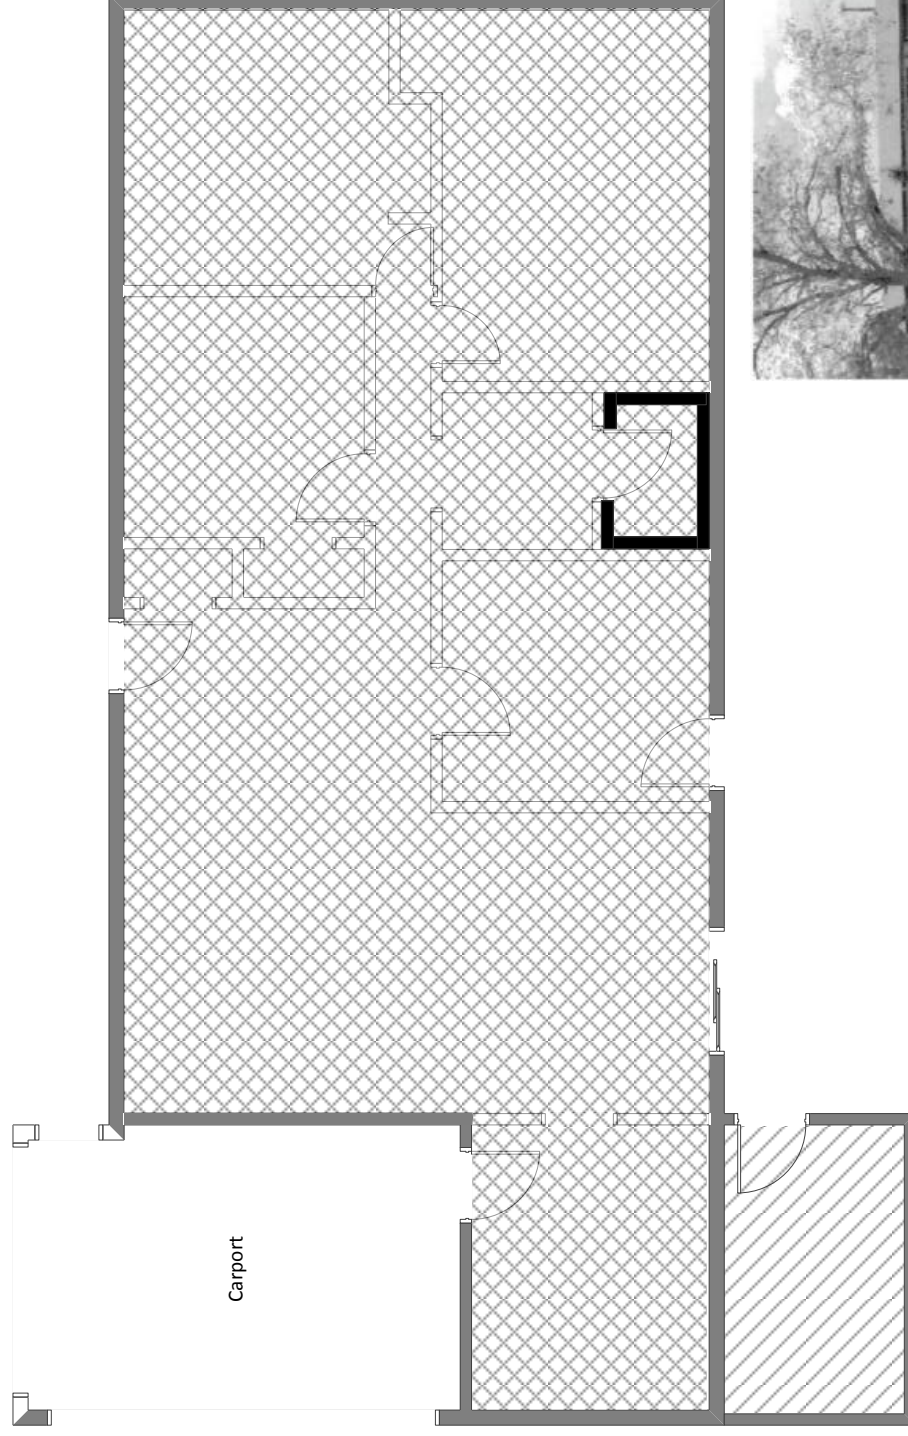
Figure 2
Unit L101
ACBM Location Plan

- ACM not shown:

- Exterior Stucco around entire building
- HVAC Sealant on ductwork throughout

ACM black flooring mastic

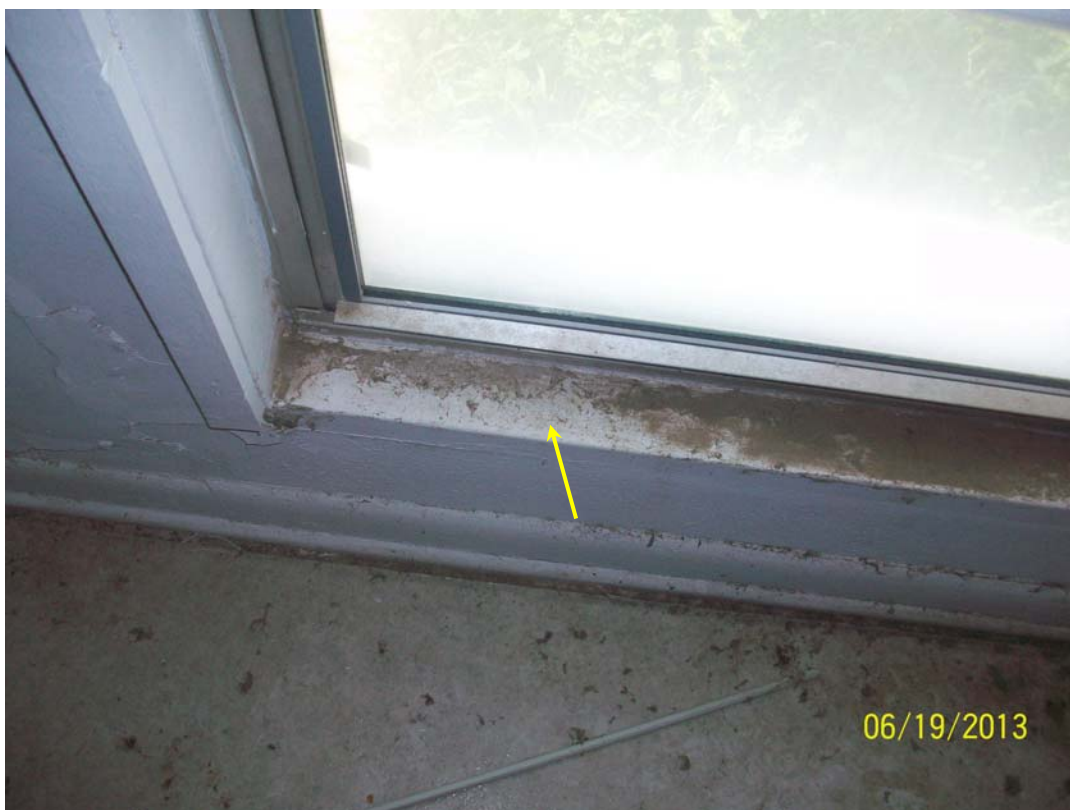
Photograph 2: View of Room 1 Windowsill which was found to be positive for LBP.

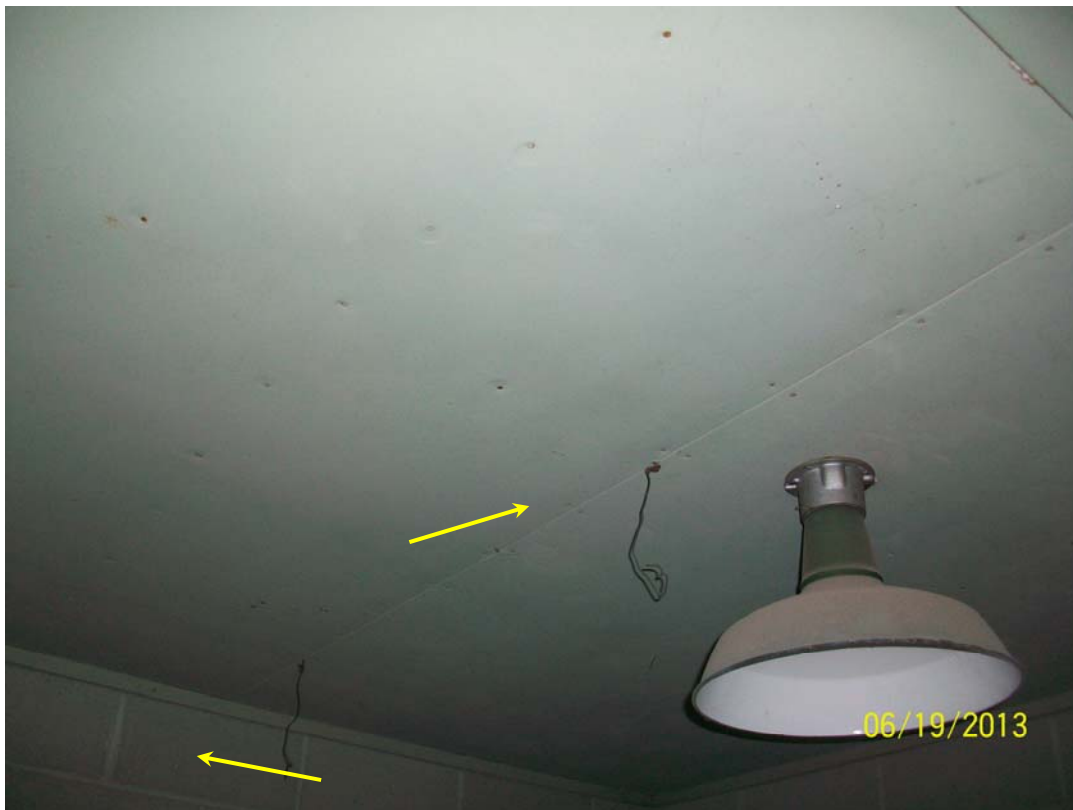
Photograph 3: View of Room 2 Ceiling and Wall B which were found to be positive for LBP.

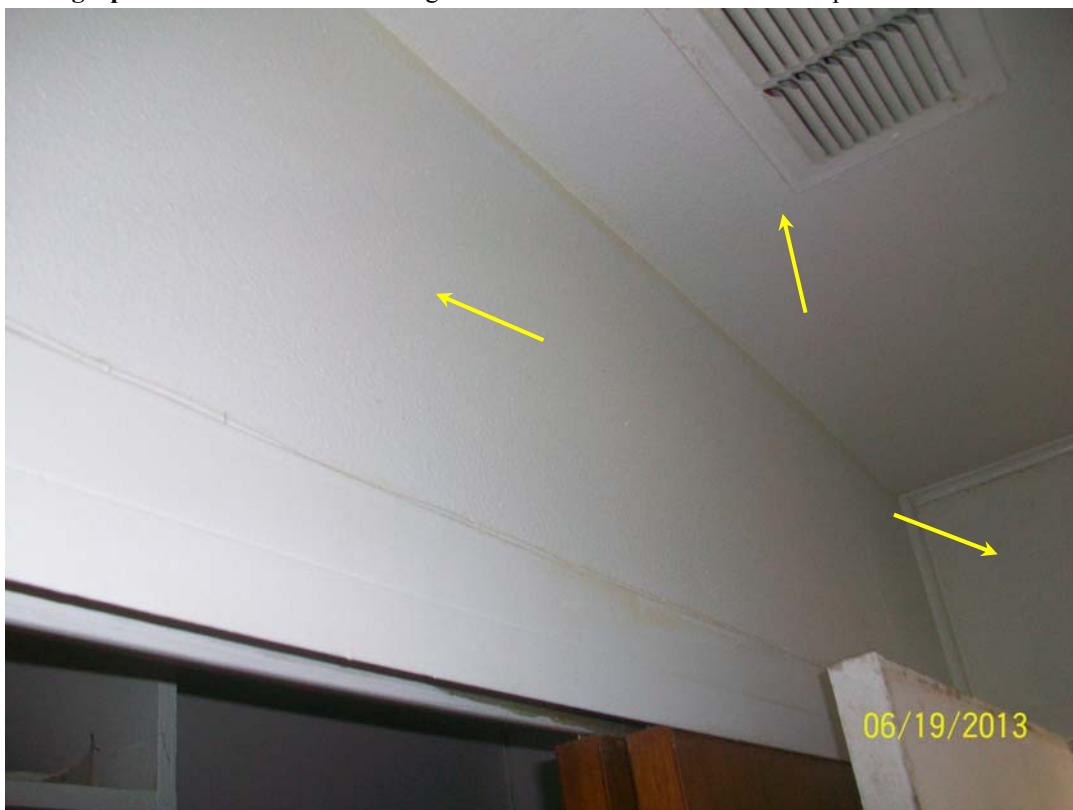
Photograph 4: View of Room 3 Ceiling, Walls A and B which were found to be positive for LBP.

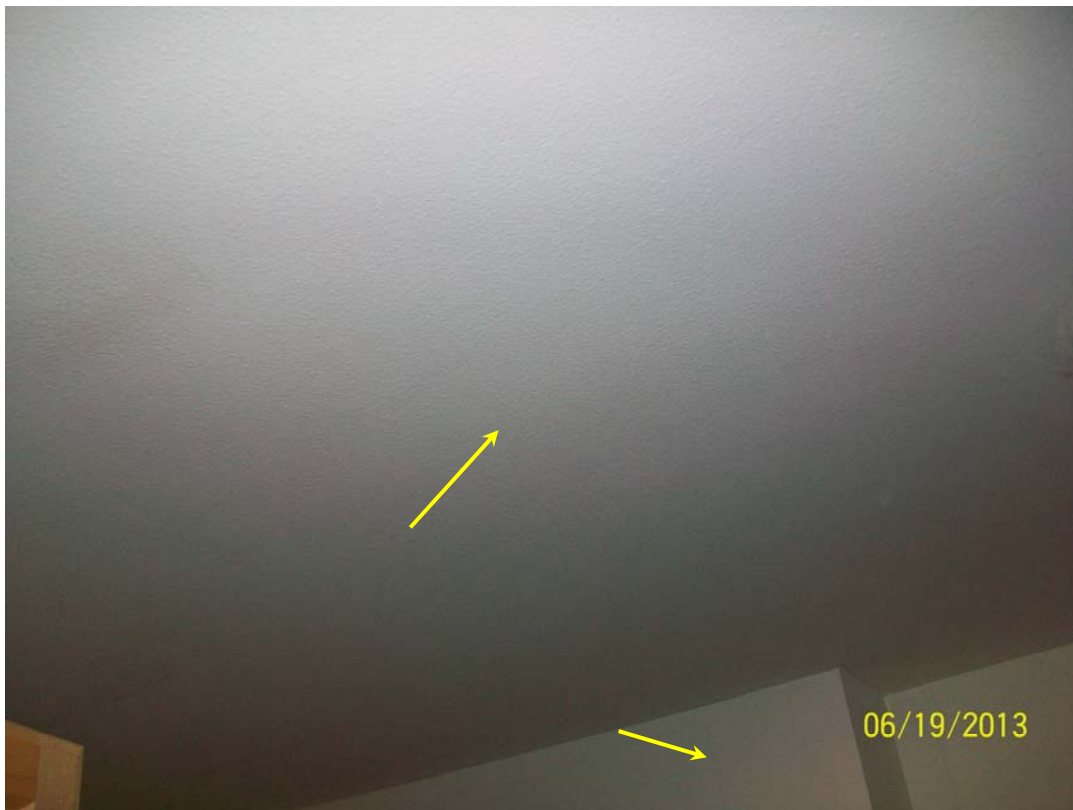
Photograph 5: View of Room 4 Ceiling and Wall A which were found to be positive for LBP.

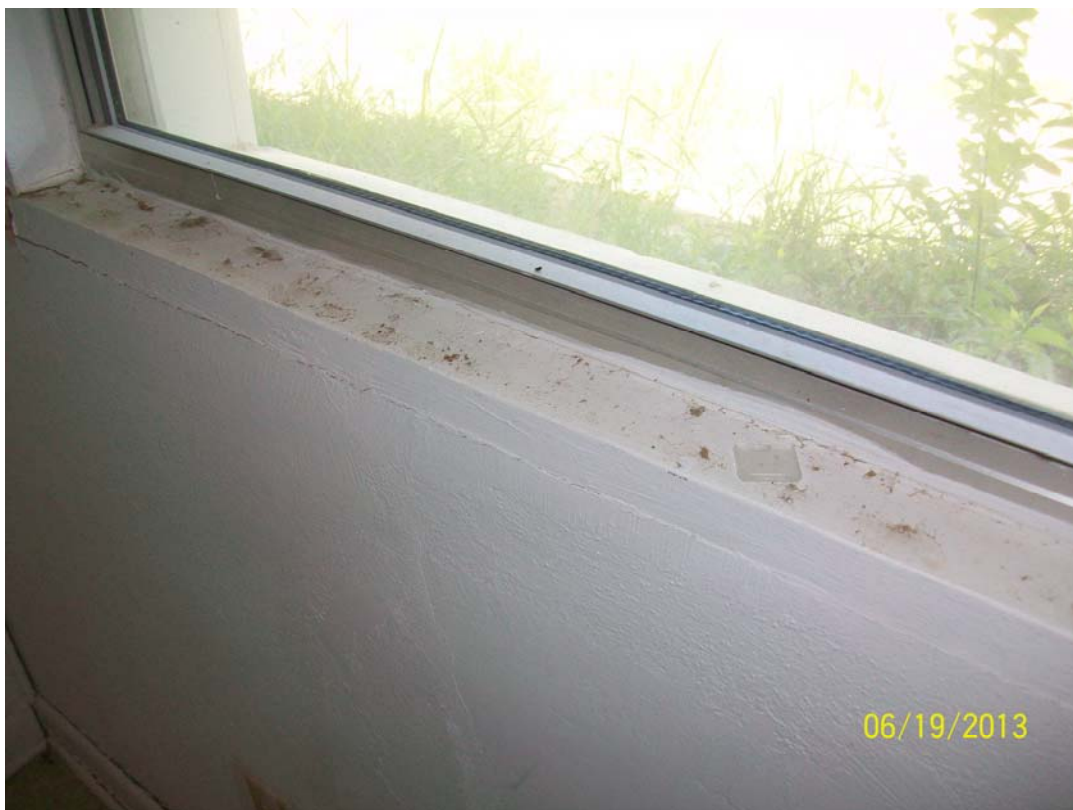
Photograph 6: View of Room 5 Windowsill which was found to be positive for LBP.

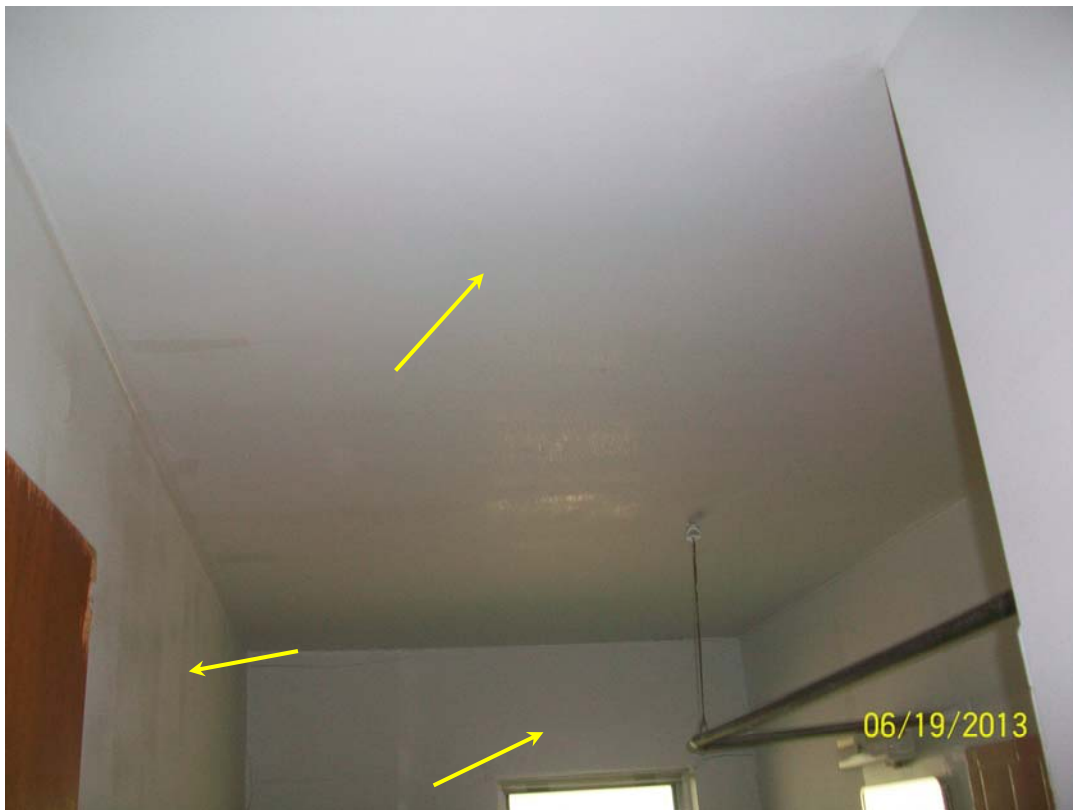
Photograph 7: View of Room 6 Ceiling and Walls A & B which were found to be positive for LBP.

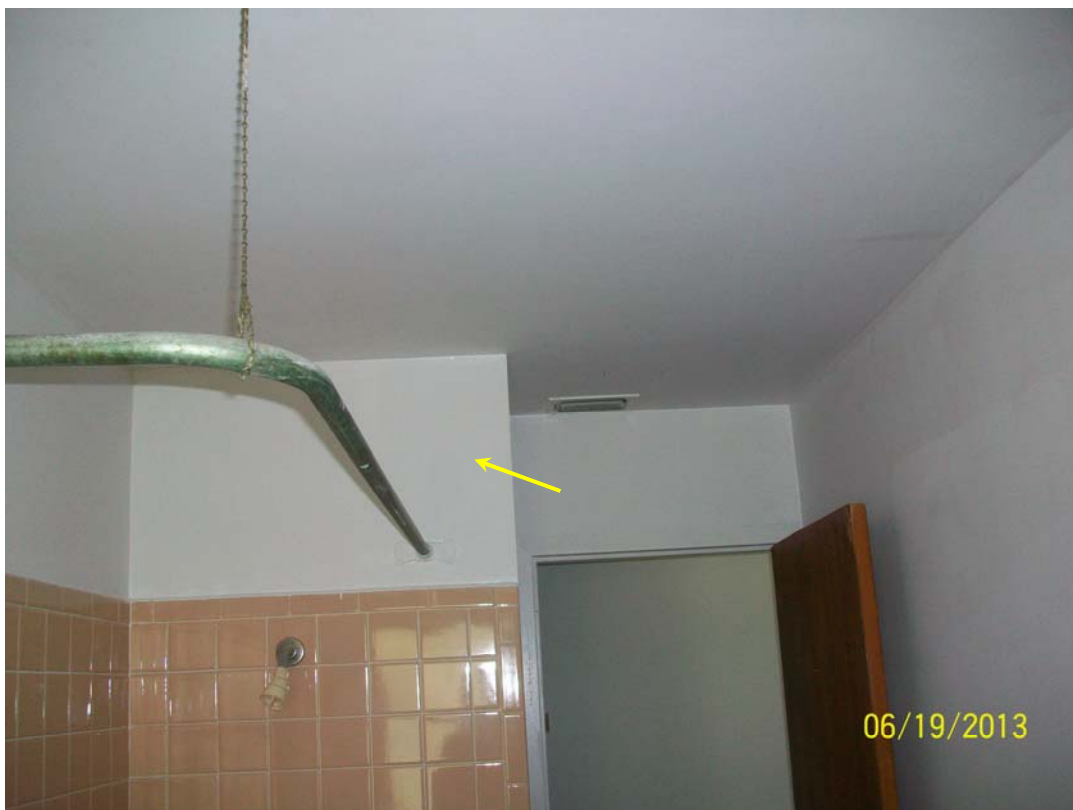
Photograph 8: View of Room 6 Wall D which was found to be positive for LBP.

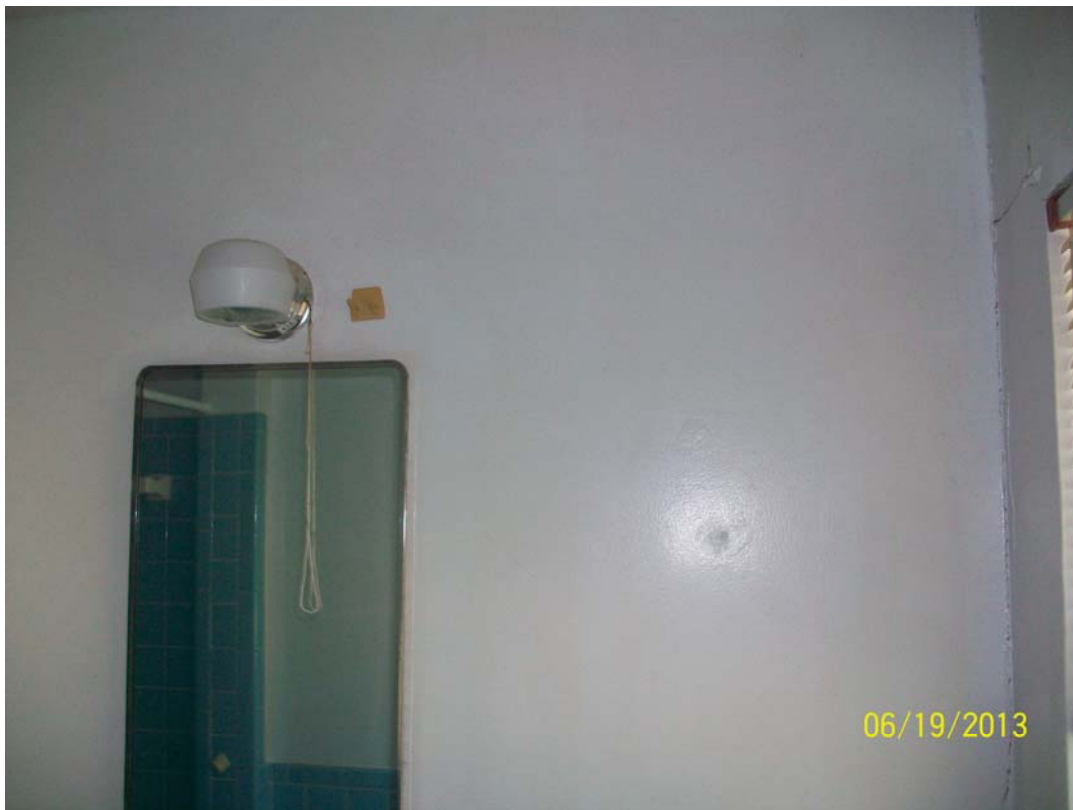
Photograph 9: View of Room 7 Wall B which was found to be positive for LBP.

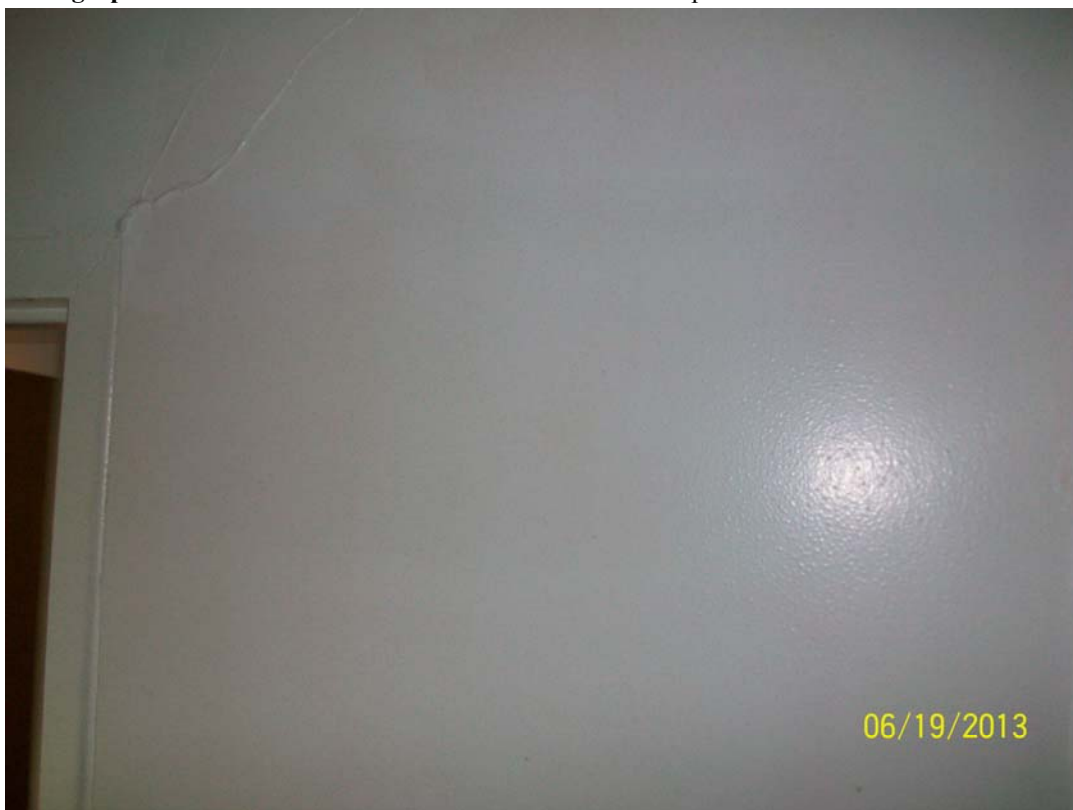
Photograph 10: View of Room 7 Wall D which was found to be positive for LBP.

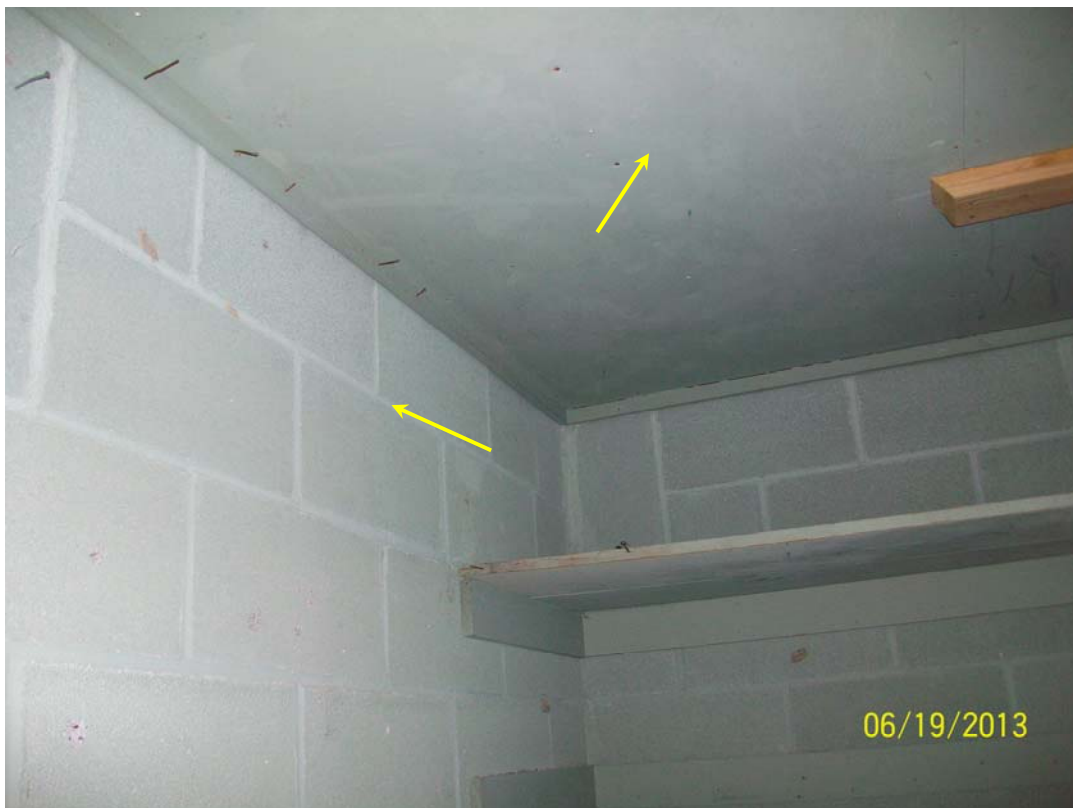
Photograph 2: View of Room 2 Ceiling and Wall A which were found to be positive for LBP.

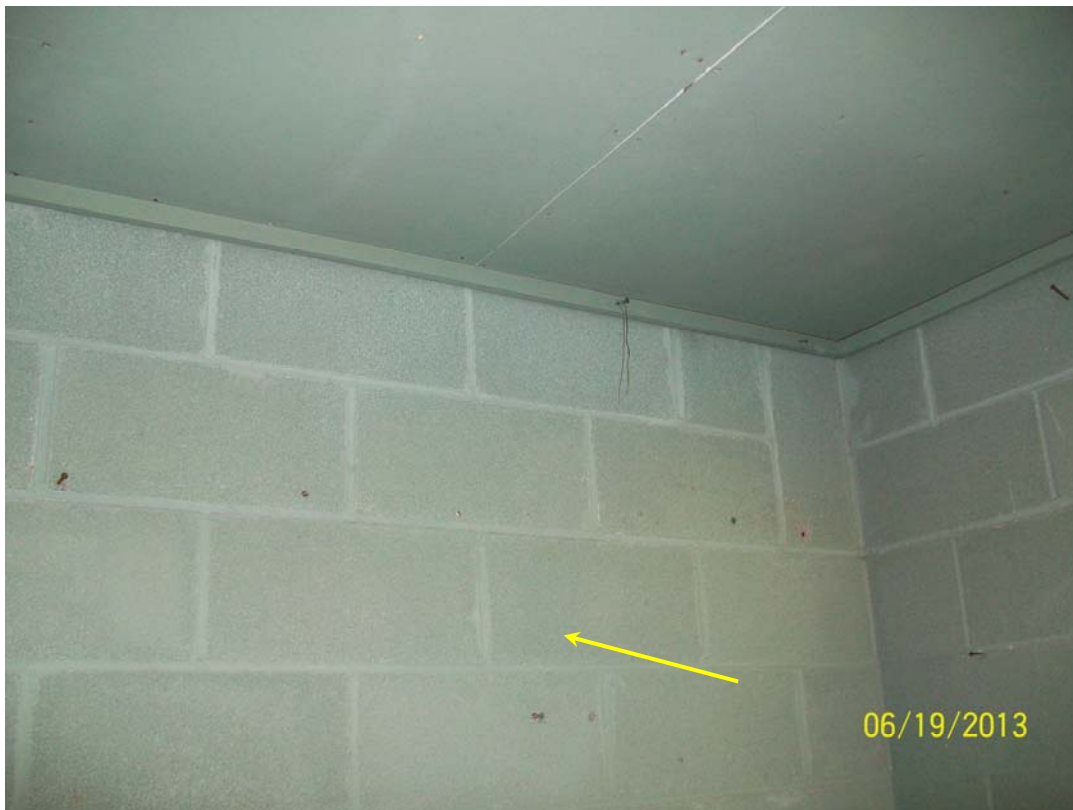
Photograph 3: View of Room 2 Wall C which was found to be positive for LBP.

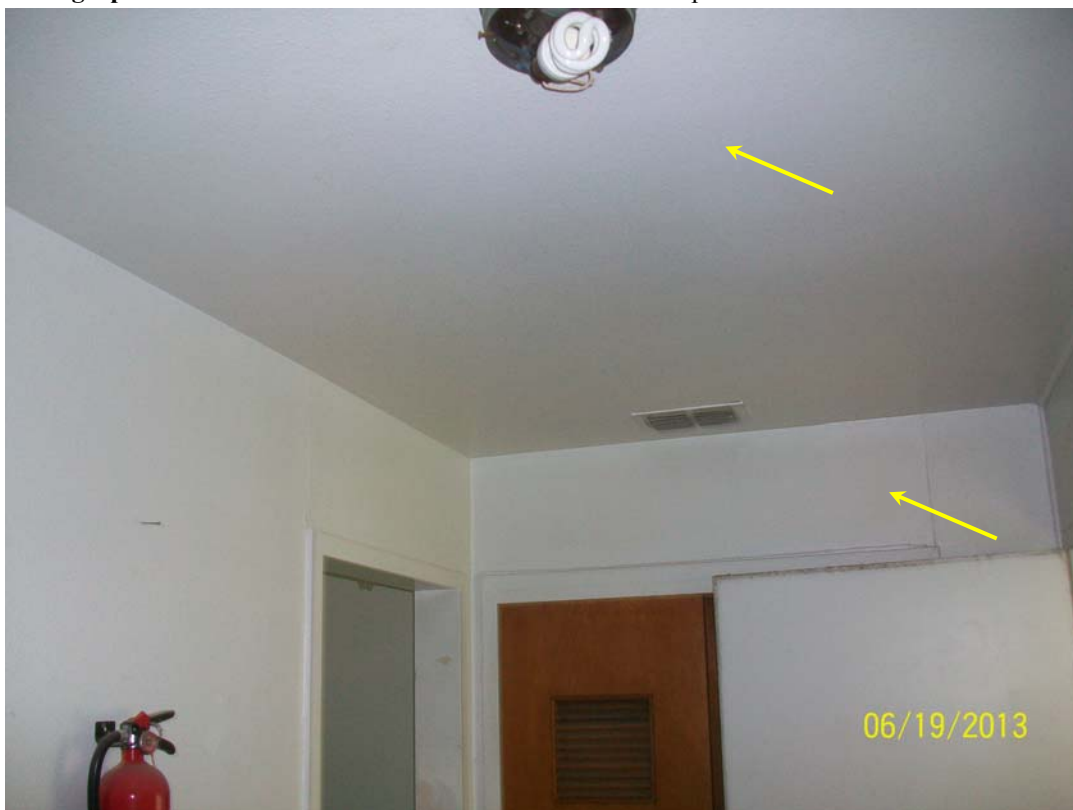
Photograph 4: View of Room 3 Ceiling and Wall A which were found to be positive for LBP. Wall C (not pictured) was also found positive for LBP.

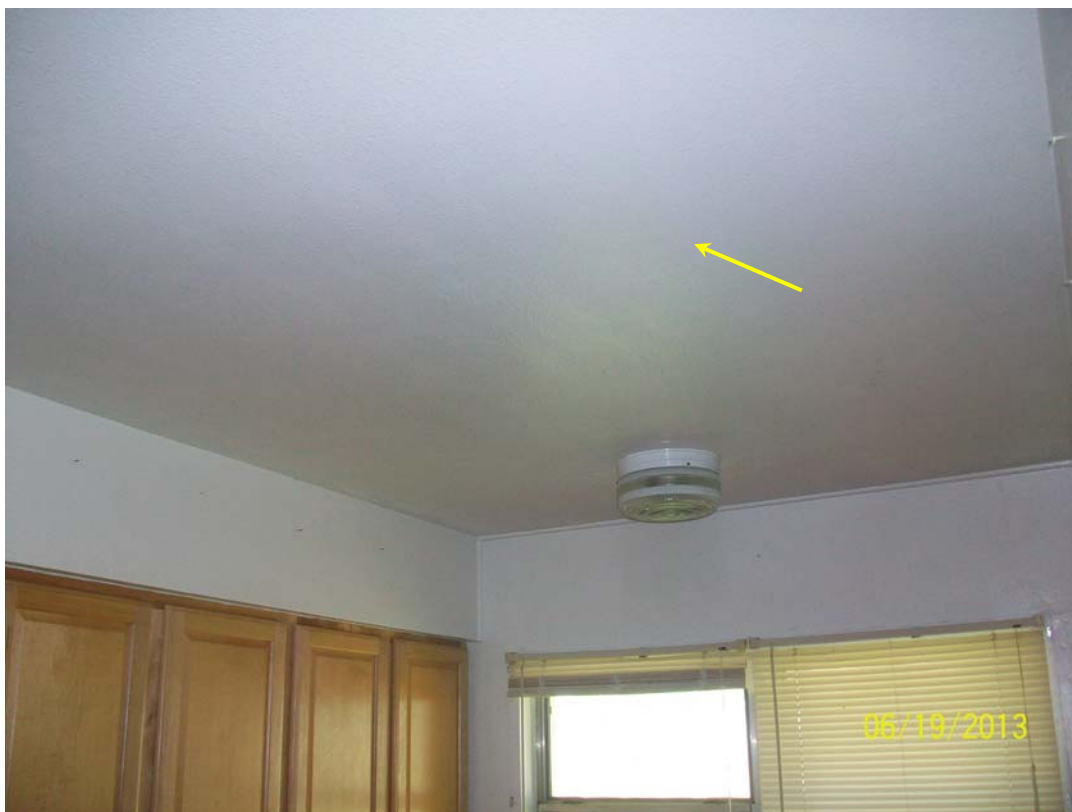
Photograph 5: View of Room 4 Ceiling which was found to be positive for LBP.

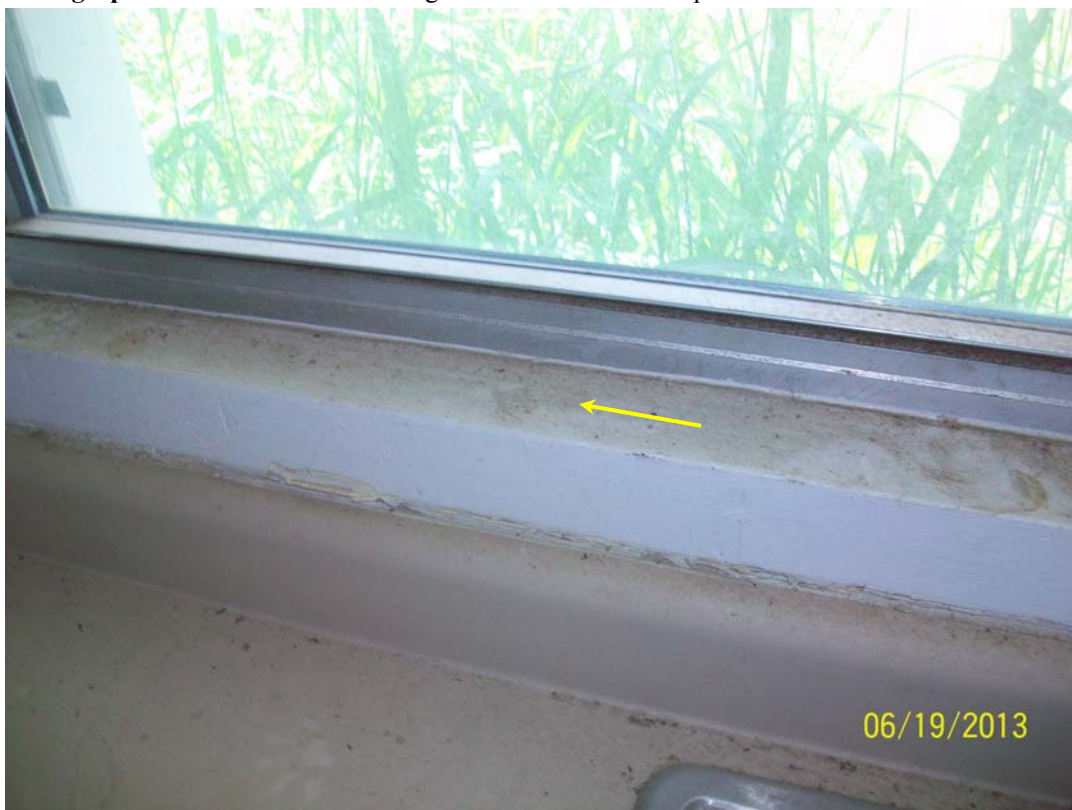
Photograph 6: View of Room 4 Windowsill which was found to be positive for LBP.

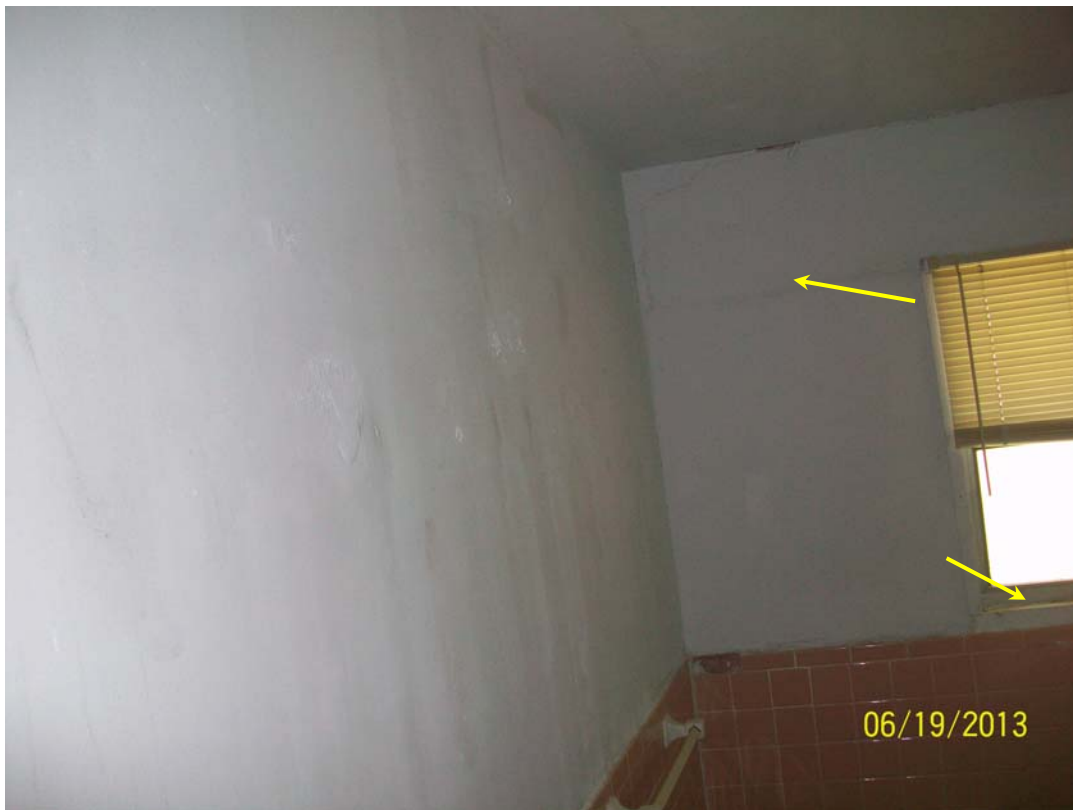
Photograph 7: View of Room 6 Wall B and Windowsill which were found to be positive for LBP.

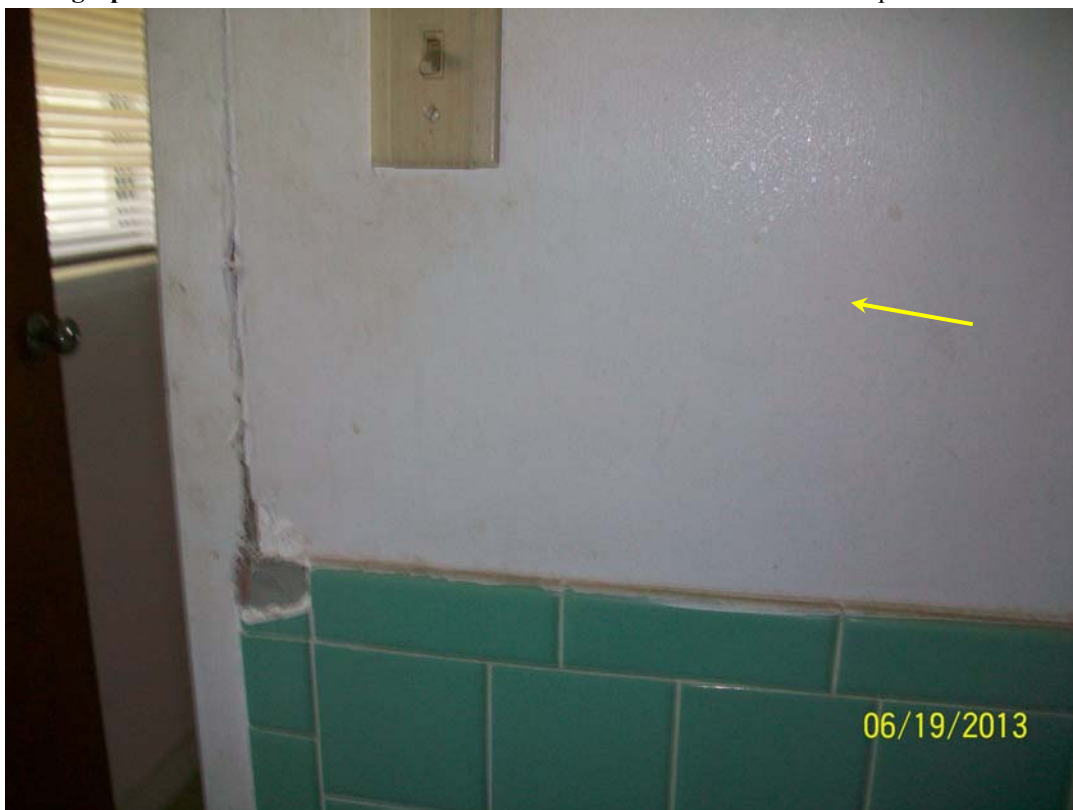
Photograph 8: View of Room 7 Wall D which was found to be positive for LBP.

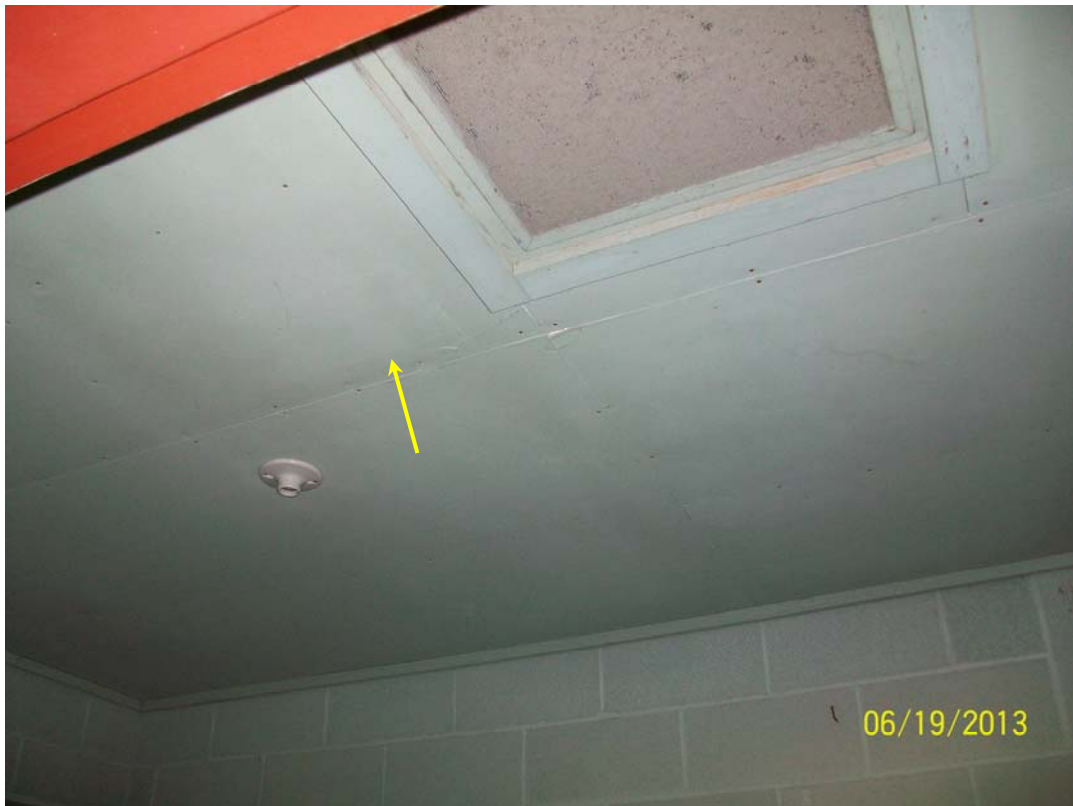
Photograph 2: View of Room 2 Ceiling which was found to be positive for LBP.

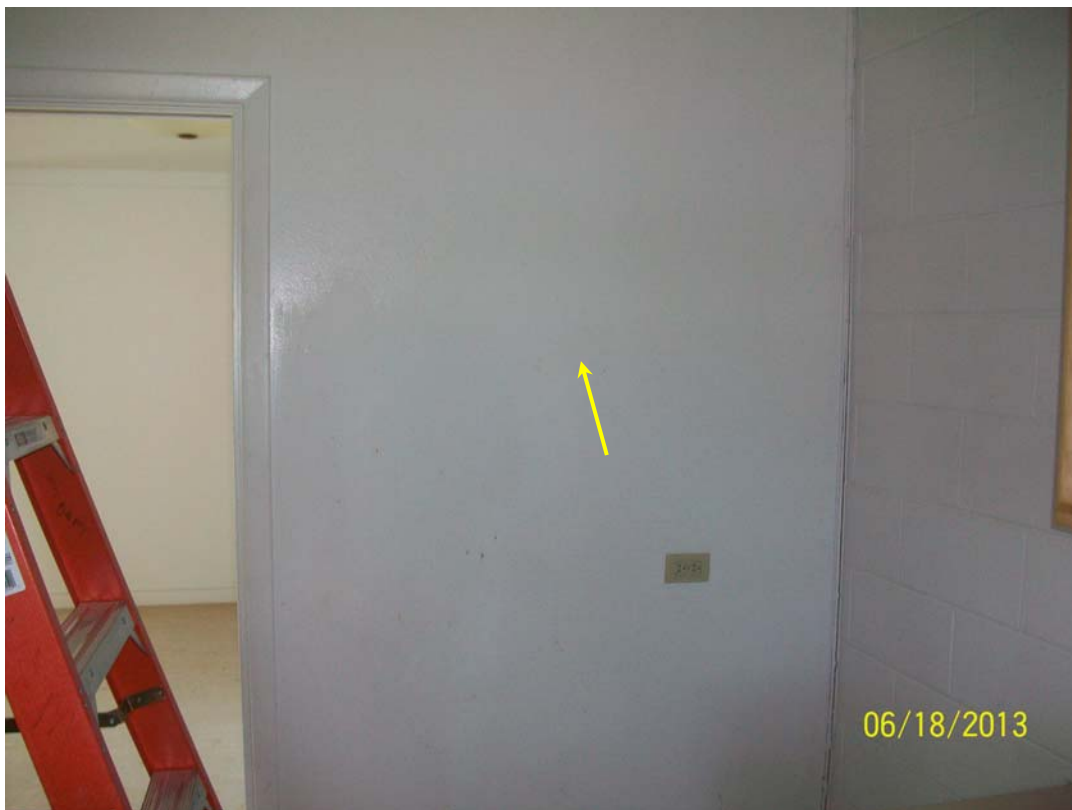
Photograph 2: View of Room 9 Wall B which was found to be positive for LBP.
