ACM and LBP Survey Data and Reports

Limited Asbestos Inspection

Project Site: Unit C102 - Single Family Dwelling
Falcon Village, Texas 78545

LCA Project No.: 130602

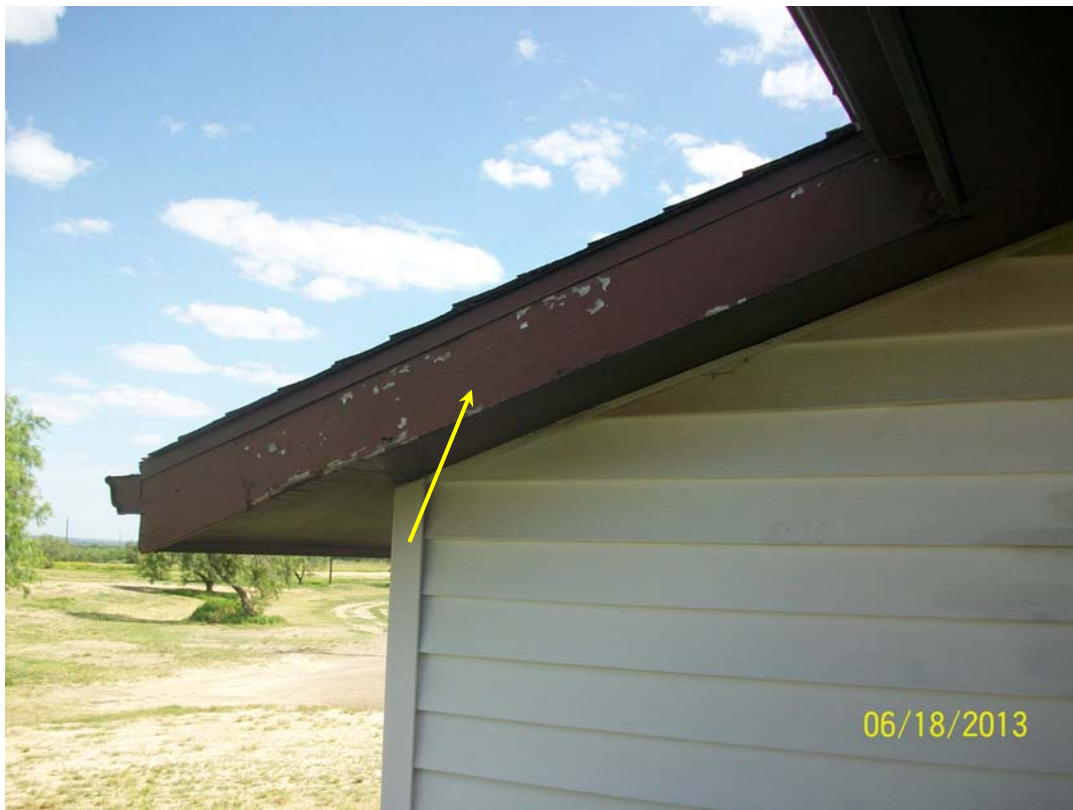
Photograph 3: View of Exterior C Fascia which was found to be positive for LBP.
