ENVIRONMENTAL STEWARDSHIP SUMMARY REPORT

OF THE CONSTRUCTION, OPERATION, AND MAINTENANCE

OF TACTICAL INFRASTRUCTURE

PEDESTRIAN FENCE SEGMENTS BV-1, B-2, B-4, B-5A, AND B-5B

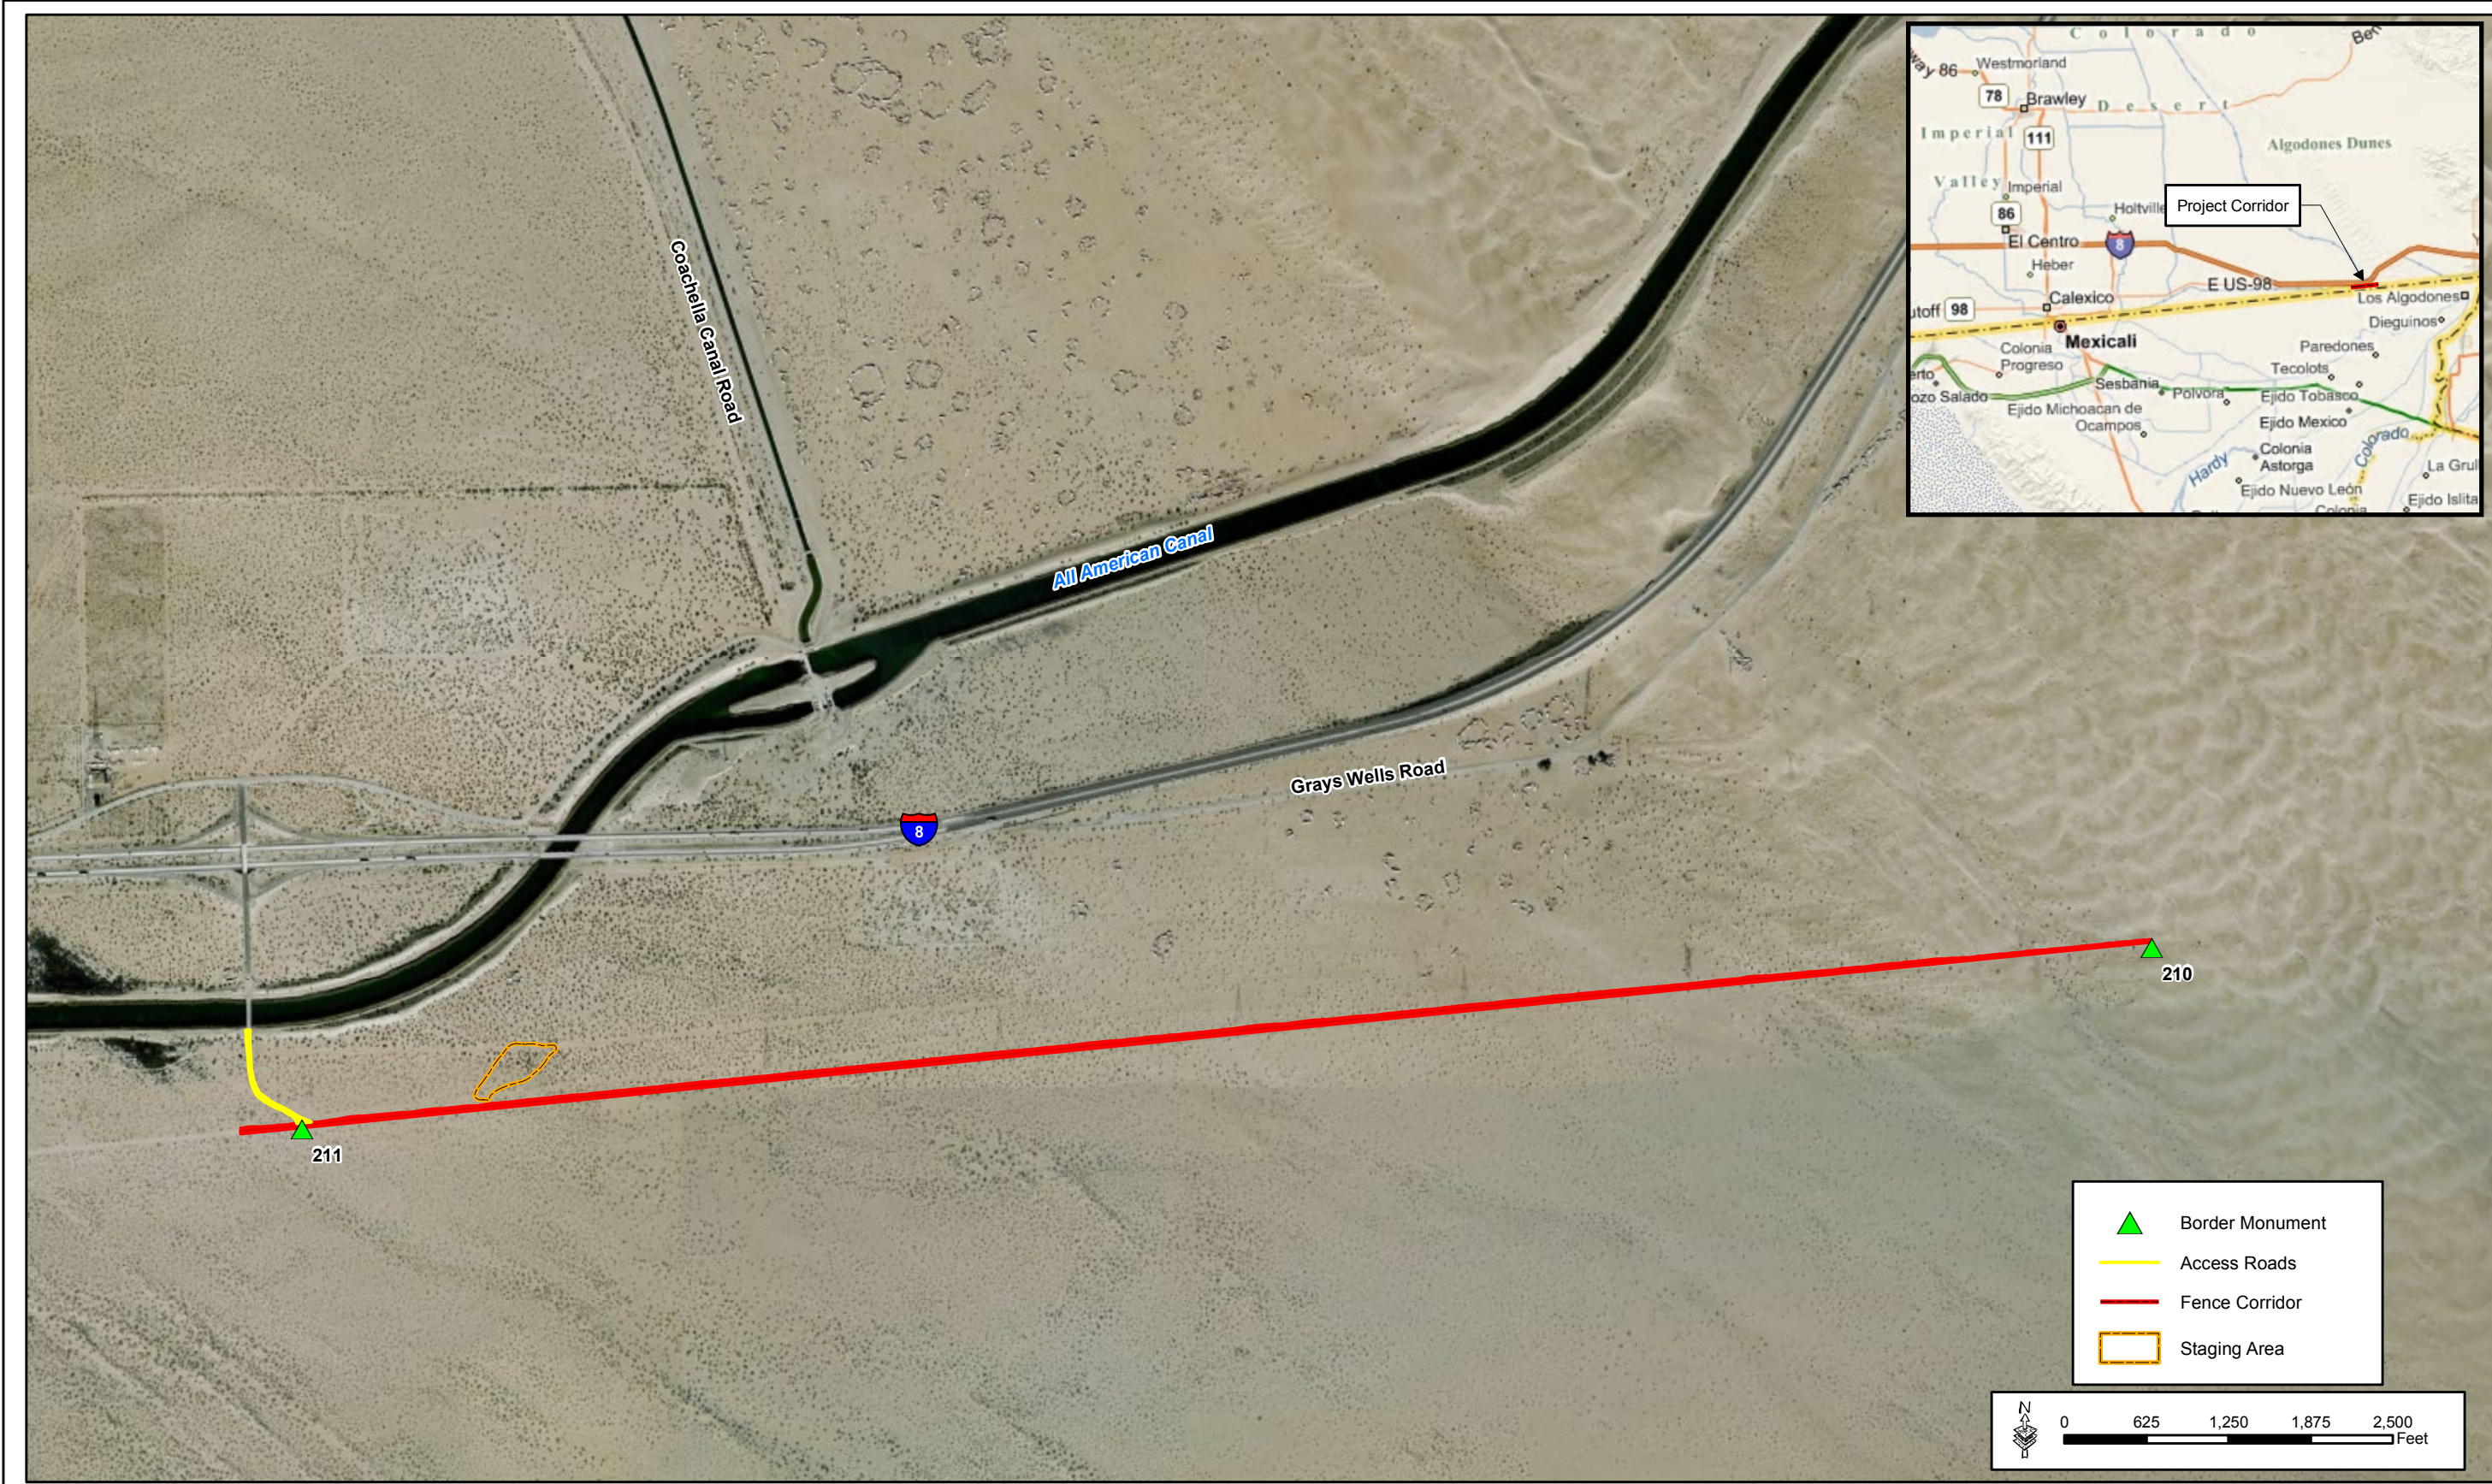
Figure 3-5: B-5B Post-Construction Map

No new access roads were proposed for the B-5B segment. Post-construction surveys recorded approximately 0.17 mile of new road, with a total impact area of 0.57 acre. No CR was approved for this increase.

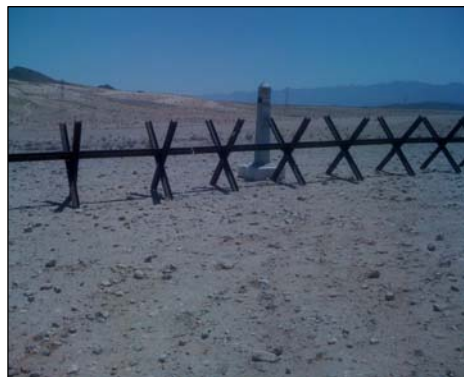
Photograph 3-1. VF-2 Fence

A post-construction survey reported that the fence and adjacent access road footprint encompassed the 60-foot-wide Roosevelt Reservation, which was the planned footprint delineated in the ESP. The analysis in the ESP anticipated that 11.3 miles of primary vehicle fence (VF-2) would be installed in the BV-1 project corridor. The post-construction survey established that 12.98 miles of VF-2 fence were installed (Photograph 3-1), or approximately 1.7 miles more than the ESP expected. No CR was approved for this increase.

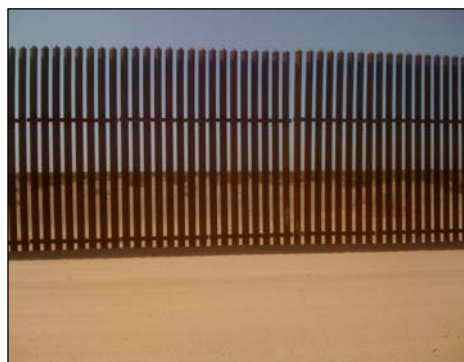
Photograph 3-2. P-2 Fence Style

The ESP stated that the B-5A segment would have 19.3 miles of PV-1 installed, although a CR was approved to increase the amount from 19.16 to 19.27 miles. The fence type for B-5A was originally PV-1, but another CR was approved to change it to P-2 (Photograph 3-2), due to increased demand for this fence type for other PV-1 segments. The post-construction survey confirmed that 19.3 miles of PV-1 and P-2 fence were installed. Caps has not been installed on top of all bollards, as of the survey

conducted for this ESSR. However, CBP reported that the capping was completed by the end of construction.

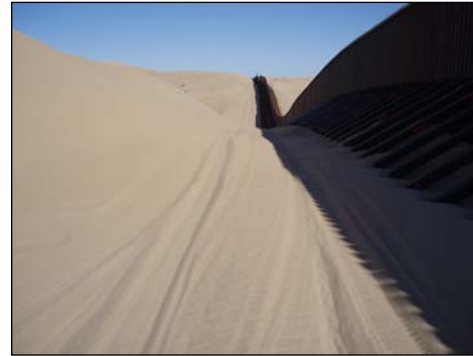
PHOTOGRAPH 3-3. PV-4 FENCE TYPE

The B-5B project corridor is 3.0 miles long, begins at the eastern terminus of segment B-5A, and ends at monument 210. A portion of B-5B is within the Imperial Sand Dunes Recreation Area. The ESP stated that a primary pedestrian fence of special design for dune conditions (PV-4) would be installed in this segment. No access roads or staging areas were planned for this segment (Figure 2-5). The PV-4 design is a “floating” fence style designed specifically for dune areas. It facilitates maintenance by allowing fence sections to be lifted with a forklift and repositioned on the sand surface whenever sand accumulates along the fence.

The ESP stated that the B-5B segment would have three miles of PV-4, primary pedestrian fence of special design for dune conditions (Photograph 3-3). The post-construction survey confirmed that 2.77 miles of fence were installed, approximately 0.23 mile less than planned in the ESP.

The post-construction survey identified one additional issue that would require some consideration: the manner in which the floating fence is maintained. As discussed in section 2.5 of this ESSR, the PV-4 fence was designed to be lifted using forklifts, and repositioned on the sand surface whenever sand accumulated along the fence. The post-construction survey team observed holes under the fence, which were reportedly caused by wind. These holes were backfilled with a front-end loader, using sand from within the 60-foot Roosevelt Reservation as borrow material. CBP is implementing a Comprehensive Tactical Infrastructure Maintenance and Repair (CTIMR) program to ensure the TI and related areas are maintained and repaired as needed.
