Appendix F

Biological Data and Report

LIMITED BIOLOGICAL INVESTIGATIONS REPORT

of Eight (8) Residential Properties Located in Falcon Village,
Starr County, Texas

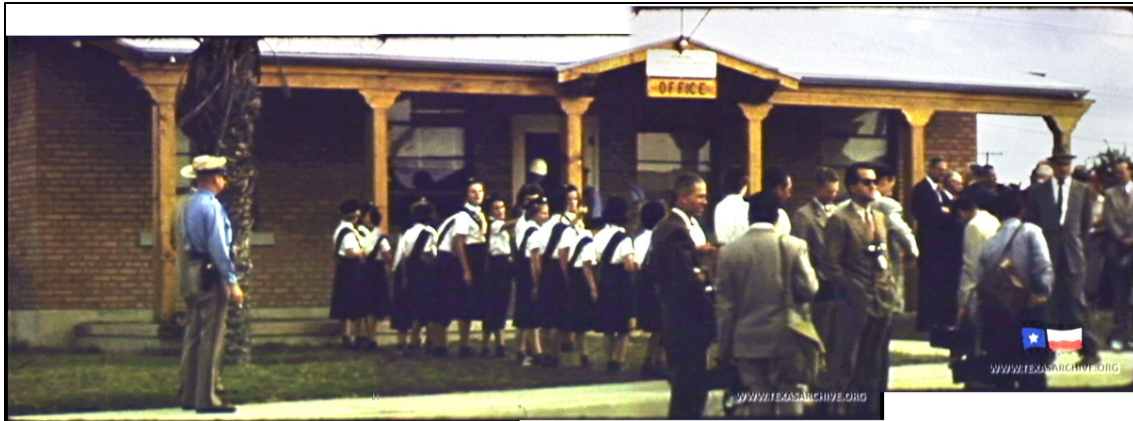
Photo 1. Composite view of Administration Building during the dedication ceremony for Falcon Dam (still image from film, courtesy of Texas Archive of the Moving Image).

Only a few historic views of the Administration Building were located. The earliest view is captured from a film made in October 1953 at the dedication ceremony for the International Falcon Dam (PHOTO 1).⁸ Prior to the ceremony, President Dwight D. Eisenhower greeted local Girl Scouts in front of the building (PHOTO 2) and was then ushered inside. A newspaper photograph of this event ran in the local paper, as well. That photograph is copyright protected, but a copy of the article taken from the newspaper on microfilm is included in the Field Records.

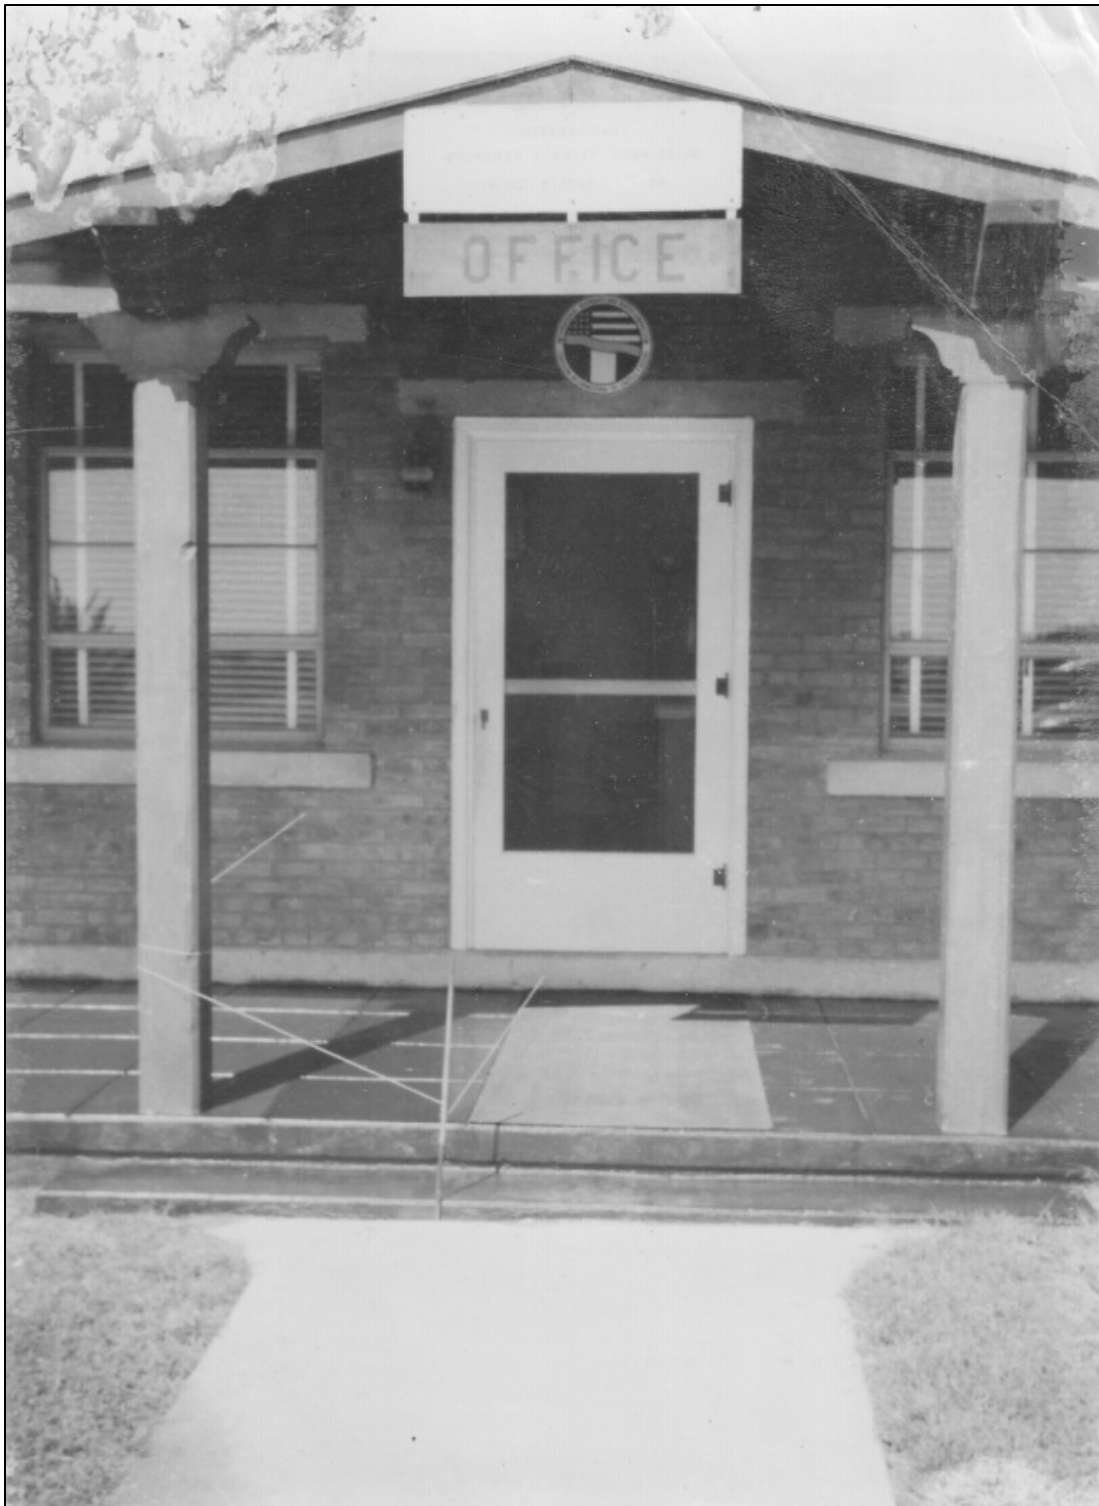
Photo 3. Photo of unknown date of the entrance to the Administration Building (photo in possession of Mr. Alberto Hinojosa, Falcon Dam Operations Manager).

A photograph of unknown date in the possession of Mr. Alberto Hinojosa, current Dam Operations Manager, shows the front of the building (PHOTO 3).⁹ It appears that the front porch was being painted at the time. The details of the plans from 1950 seem to all be intact in this photograph and constructed to specifications. A photograph from 1957 that accompanies the project completion report shows the landscaping around the building (PHOTO 4).¹⁰ Finally, a photograph showing utility work near the garage building in 1962 shows the east side of the administration building in the background (PHOTO 5).¹¹ In all of these photos, the original design of the porch and roof appear to be intact.

- a. **Doorways and doors:** The primary entrance is on the center of the south facade, with a single-leaf, wood-and-glass door that replaced the original single glass panel door at an unknown date. A screen door was also removed at an unknown date based on the original plans and a historic photograph of unknown date (PHOTO 3). Above the entrance is a concrete lintel to which is affixed a metal sign lettered with OFFICE. Above the lintel is a round metal sign with the USIBWC logo. A metal exterior light with glass panes is to the west of this door. A secondary entrance is on the west side of the north ell with a concrete sill and lintel. It has a single-leaf wood door with metal handle.

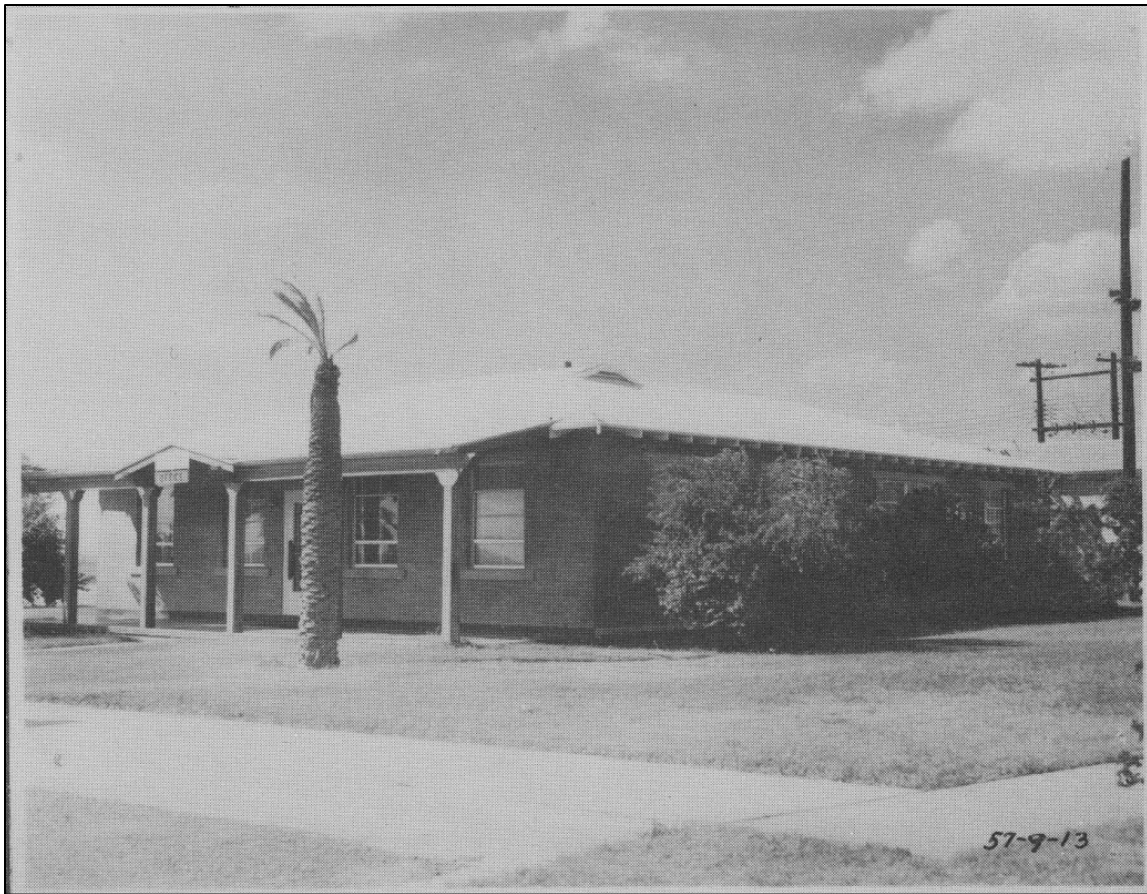
Photo 4. View of the south and east sides of the Administration Building, 12 September 1957
(photo from *Report on Construction of Falcon Dam*, 1958[?]).

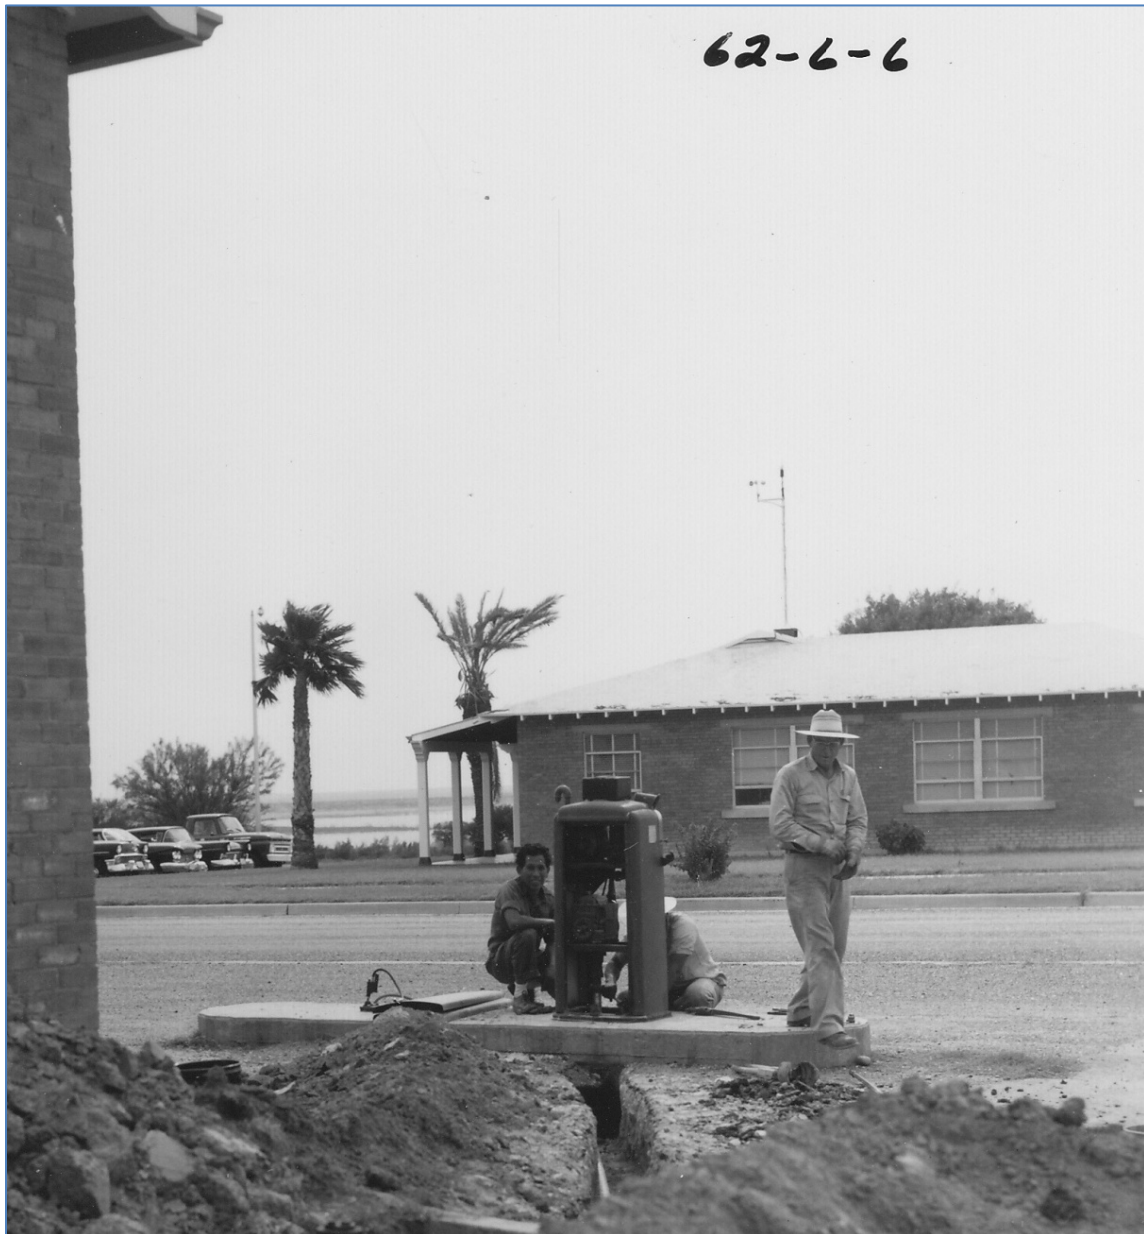
Photo 5. View of utility construction with Administration Building in background, 6 June 1962
(photo from Administration Building Vault).

No structural additions have been made to the building. A patio in the rear ell covered by a metal shed roof was added at an unknown date. The porch supports and some porch details were replaced sometime after 1962 based on the photo of that date that shows original porch supports in place (PHOTO 5).

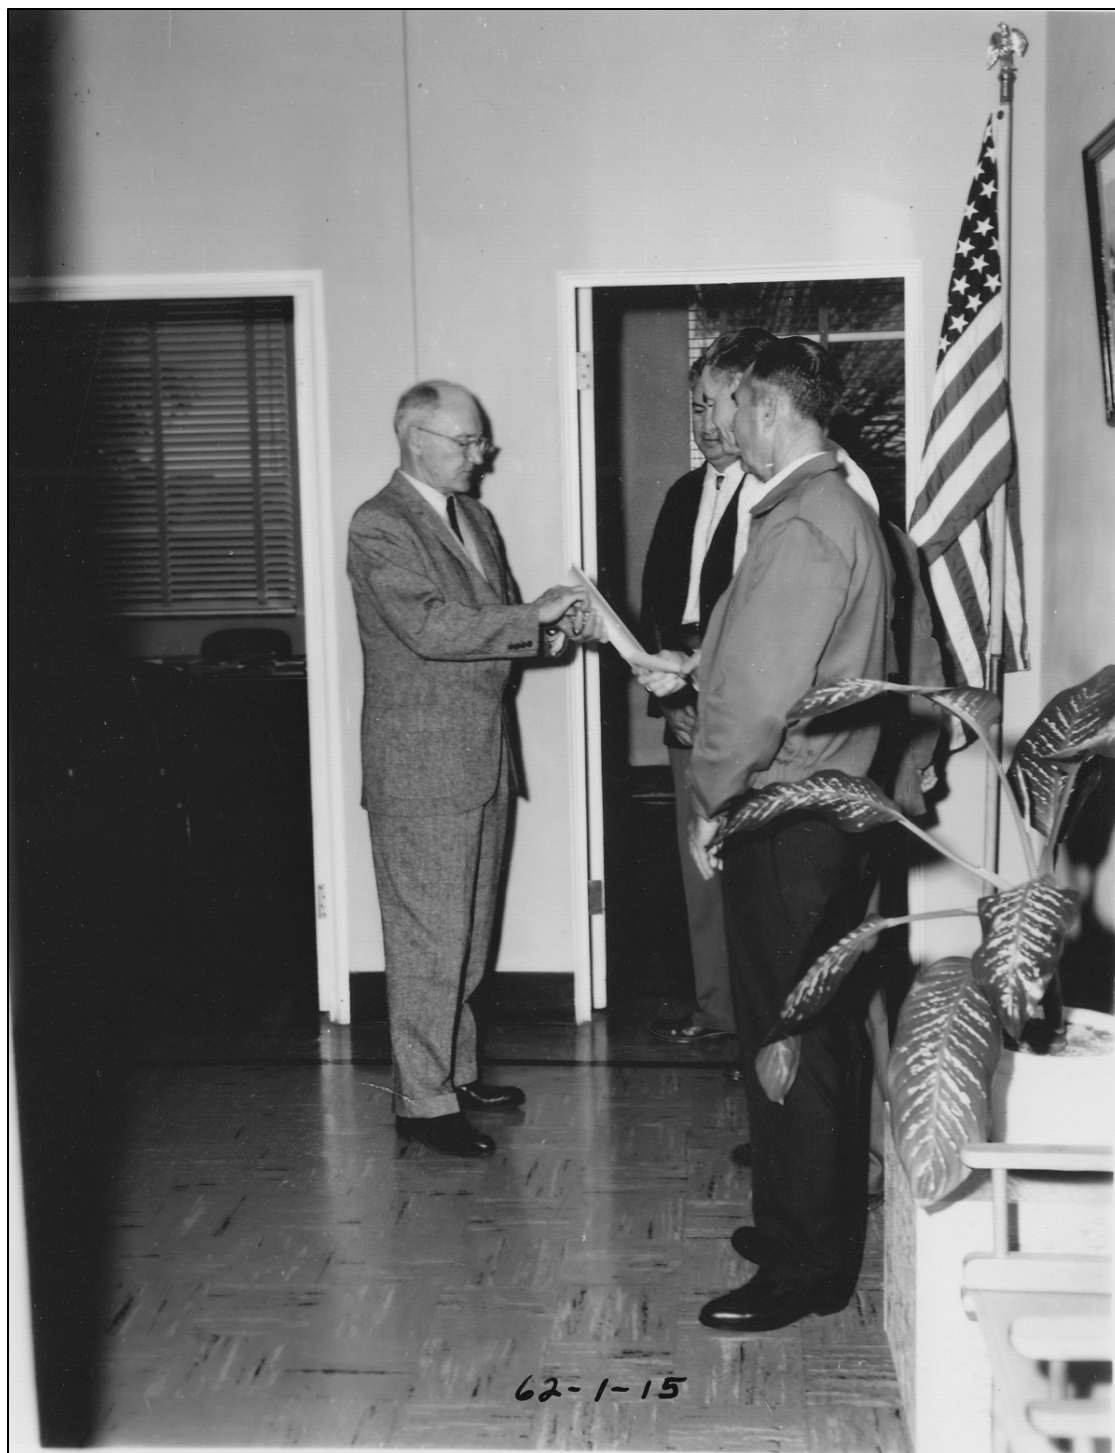
Photo 6. USIBWC employees receiving their 10-year service pins in the lobby of the Administration Building, 15 January 1962 (photo from Administration Building Vault).

A picture of several employees receiving 10-year service awards in January 1962 appears to have been taken in Administration Building lobby and is the only historic view of the building interior that was located (PHOTO 6).¹² It indicates that the wood paneling was added after that date and that the 9-inch-square asphalt tile floor was replaced after that date with a similar, but not identical, 12-inch square tile.
