# ENVIRONMENTAL STEWARDSHIP SUMMARY REPORT OF THE CONSTRUCTION, OPERATION, AND MAINTENANCE OF TACTICAL INFRASTRUCTURE PEDESTRIAN FENCE SEGMENTS L-1, L-1A, AND L-1B U.S. Border Patrol Marfa Sector, Texas

U.S. Department of Homeland Security  
U.S. Customs and Border Protection  
U.S. Border Patrol

July 2012

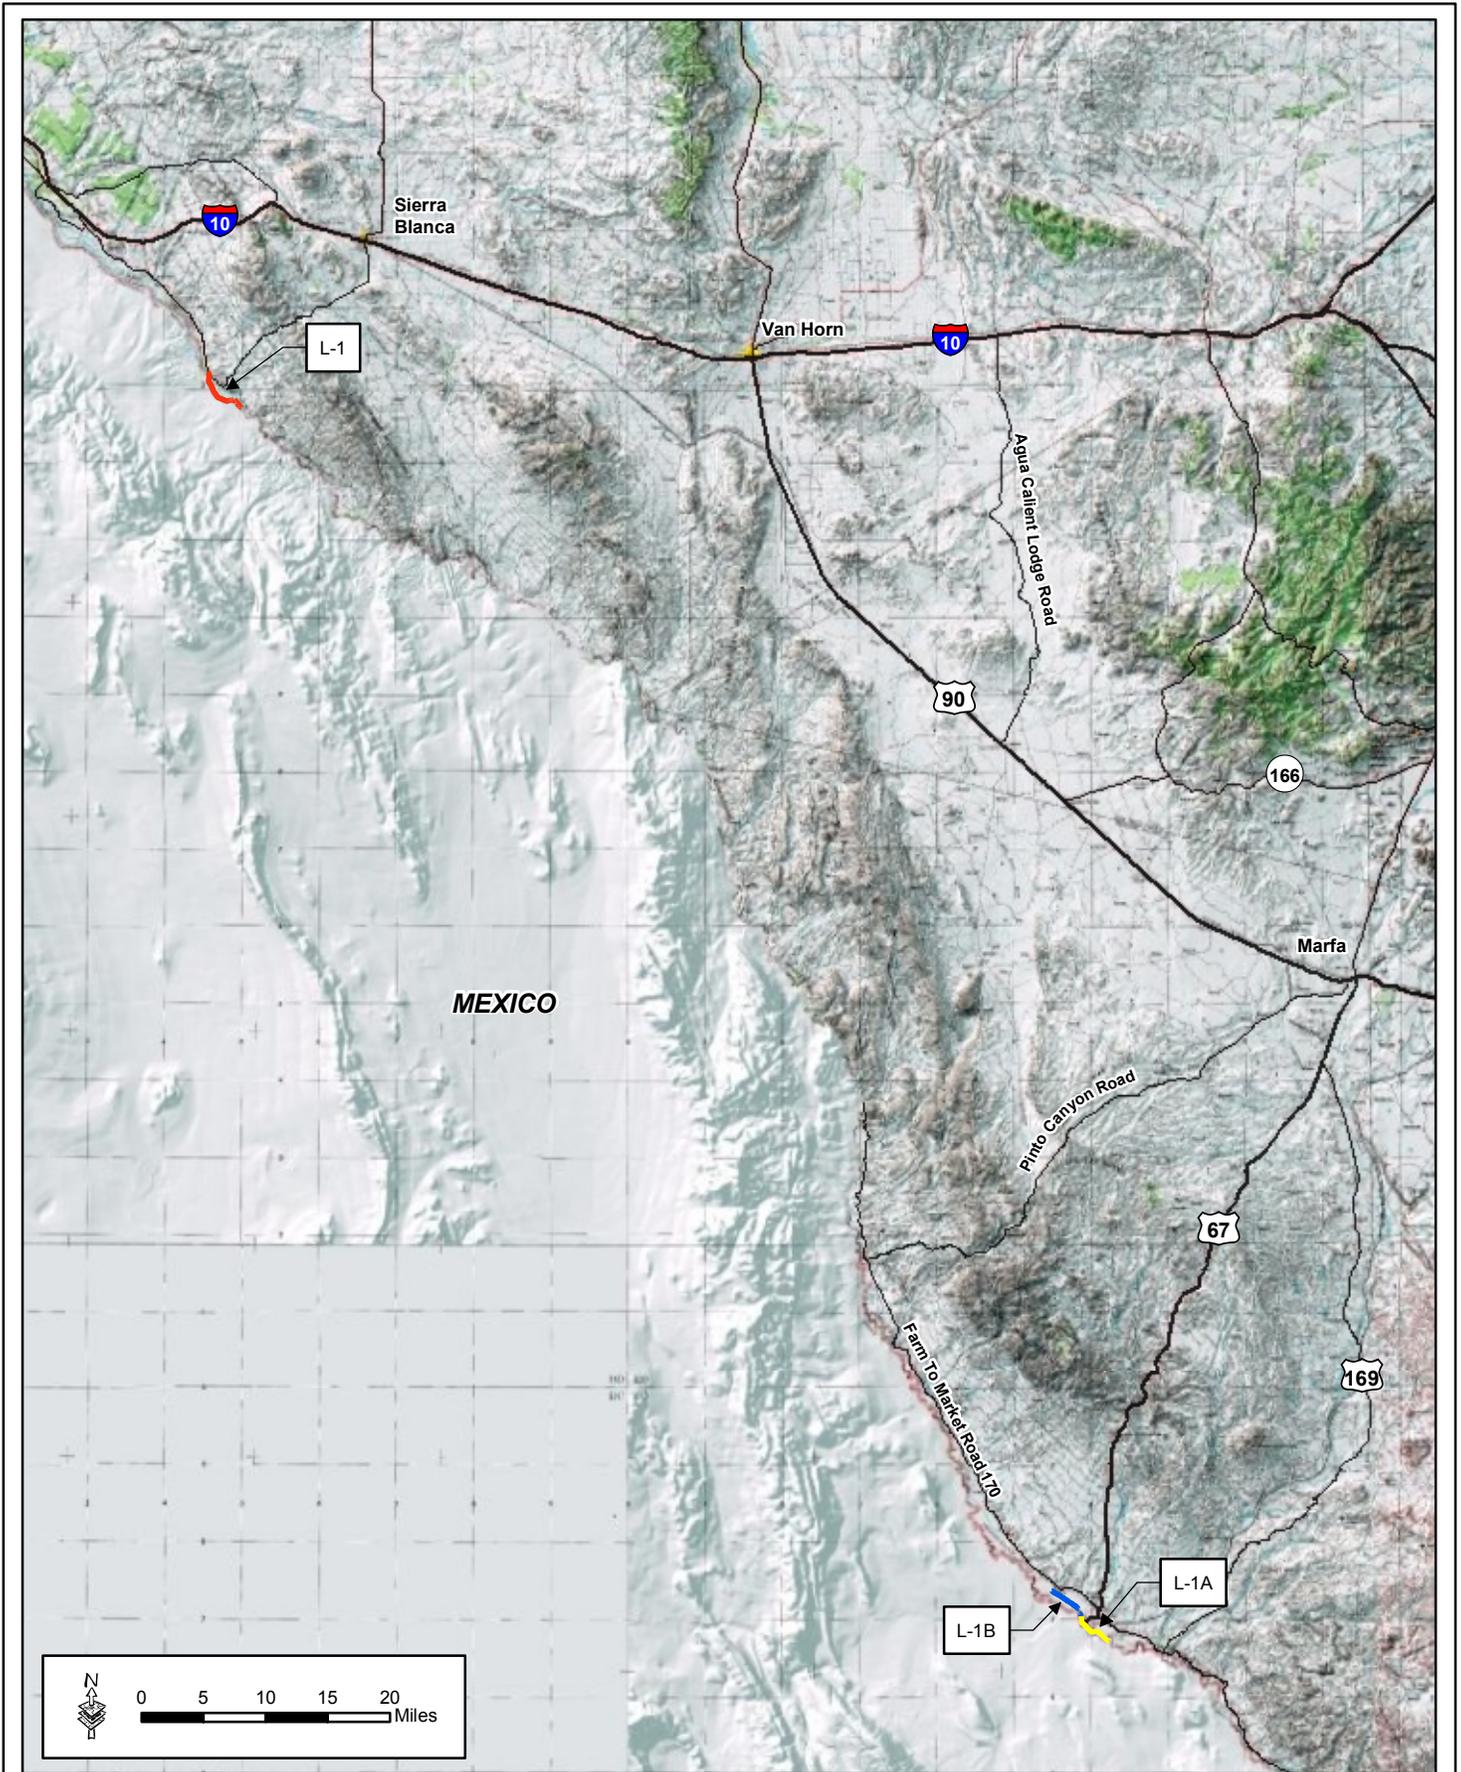
Figure 1-1: Proposed Construction Segments

Information in this ESSR was compiled from environmental monitoring reports, approved modifications made during construction, and post-construction surveys of the project corridor. Although the original ESP analyzed anticipated impacts from the construction of segments L-1, L-1A (Figure 1), and L-1B, only L-1 has been built to date. Therefore, this ESSR compares anticipated to actual impacts for segment L-1 only.

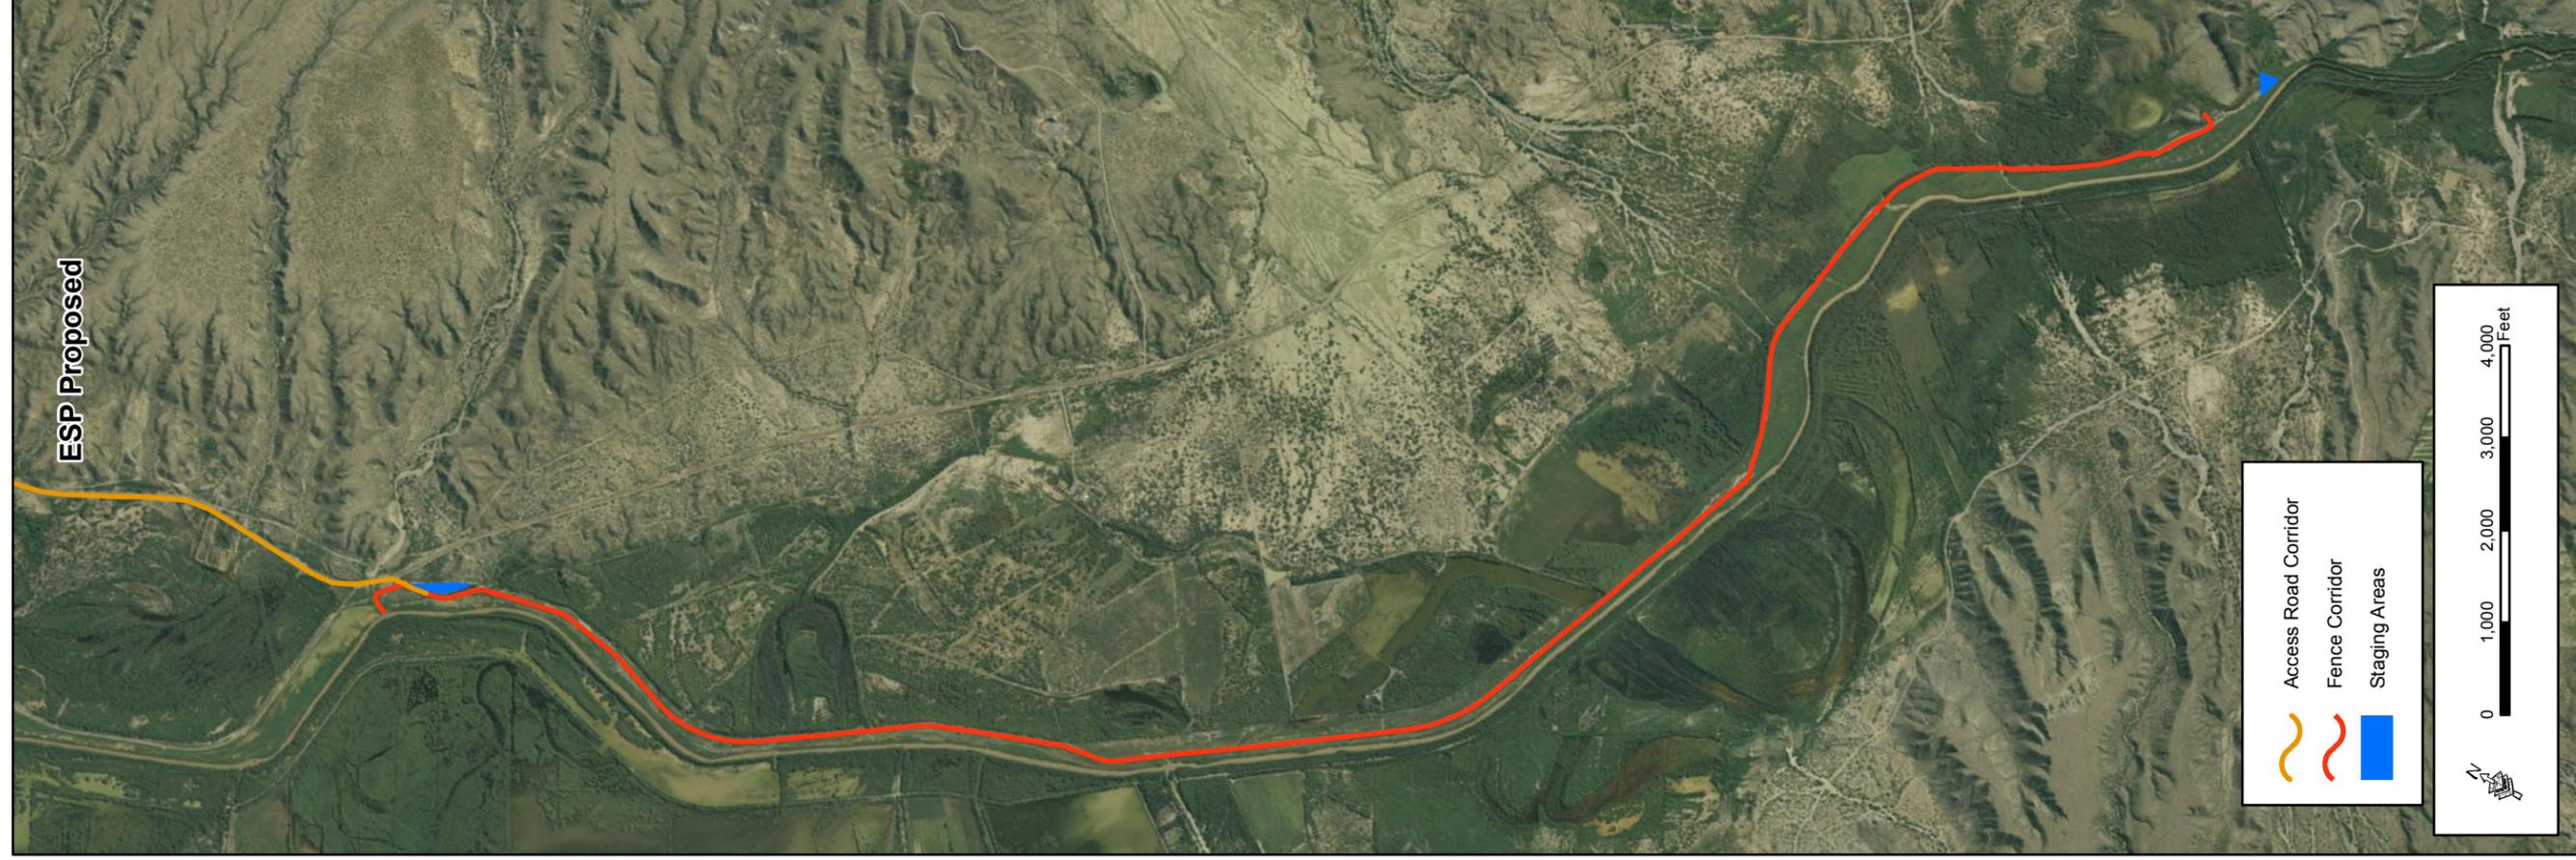
Figure 3-1: Marfa (L-1 Segment) Infrastructure Map

The access road for L-1 is a preexisting paved road (Figure 3-1). The ESP briefly discussed this access road but determined that it would need no alteration. No new access road was built. Thus, L-1 access roads caused no impacts.

Although the ESP did not indicate locations of the two planned staging areas, that information was obtained from the CBP FITT GIS data files. Based on the locations given there, the post-construction survey revealed that both staging areas were moved (see Figure 3-1).

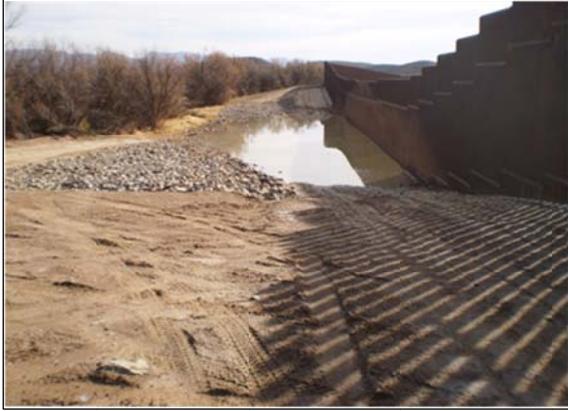
**Photograph 3-1. Bollard Fence through Low Water Crossing**

The ESP anticipated that one type of fence (PV-3) would be installed in the L-1 project corridor. The post-construction site survey confirmed that PV-3 fence was installed. In some places the concrete base was removed to facilitate the flow of water. The construction of this latter type of fence, designated as P-2, was approved through a CR (Photographs 3-1 and 3-2).

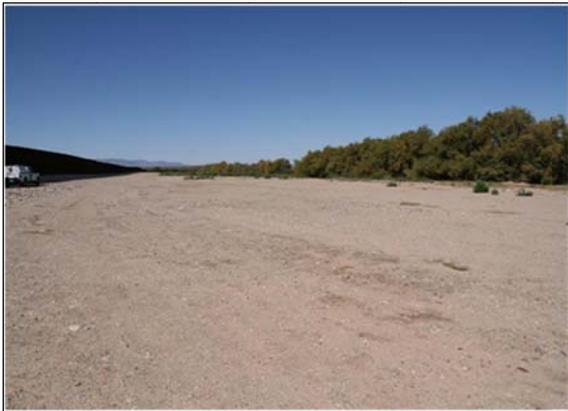
**Photograph 3-3. Northwestern Staging Area**

The northwestern planned staging area was moved approximately 2.7 miles southeast along the project corridor (Photograph 3-3). The planned southeast staging area was moved northwest approximately 0.19 mile to accommodate the concrete trench (Photograph 3-4). The post-construction survey also revealed that the staging areas increased in total size from 1.2 acres, as identified in the ESP, to 2.4 acres. No CR was approved for moving the location of the staging areas or increasing their size.

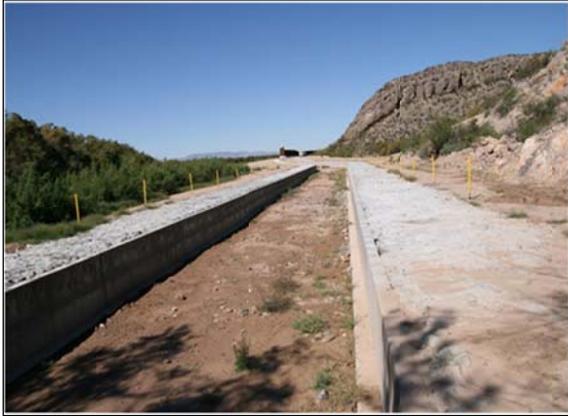
Photograph 3-5. Concrete Trench at Western End

Concrete trenches were built at each end of the L-1 project corridor (Photographs 3-5 and 3-6) to deter vehicles from attempting to circumvent the fence. These were authorized under two separate CRs. One CR authorized concrete trenches 20 feet wide by 5 feet deep by 240 feet long at each end of the PV-3 (modified) pedestrian fence. The other CR increased the length of the

The post-construction surveys recorded that the western trench was 270 feet by 45 feet and the eastern trench was 640 feet by 45 feet. When combined (910 feet total) they totaled a permanent impact of approximately 1 acre. The approved CR did not account for the extension of the eastern trench out to 640 feet in length.
