ENVIRONMENTAL STEWARDSHIP SUMMARY REPORT

**for the Construction, Operation, and Maintenance
of Vehicle Fence and Related Tactical Infrastructure,
Sections CV-2, CV-2A, and CV-1A,
Wellton Station and Yuma Station,
U.S. Border Patrol Yuma Sector, Arizona**

July 2012

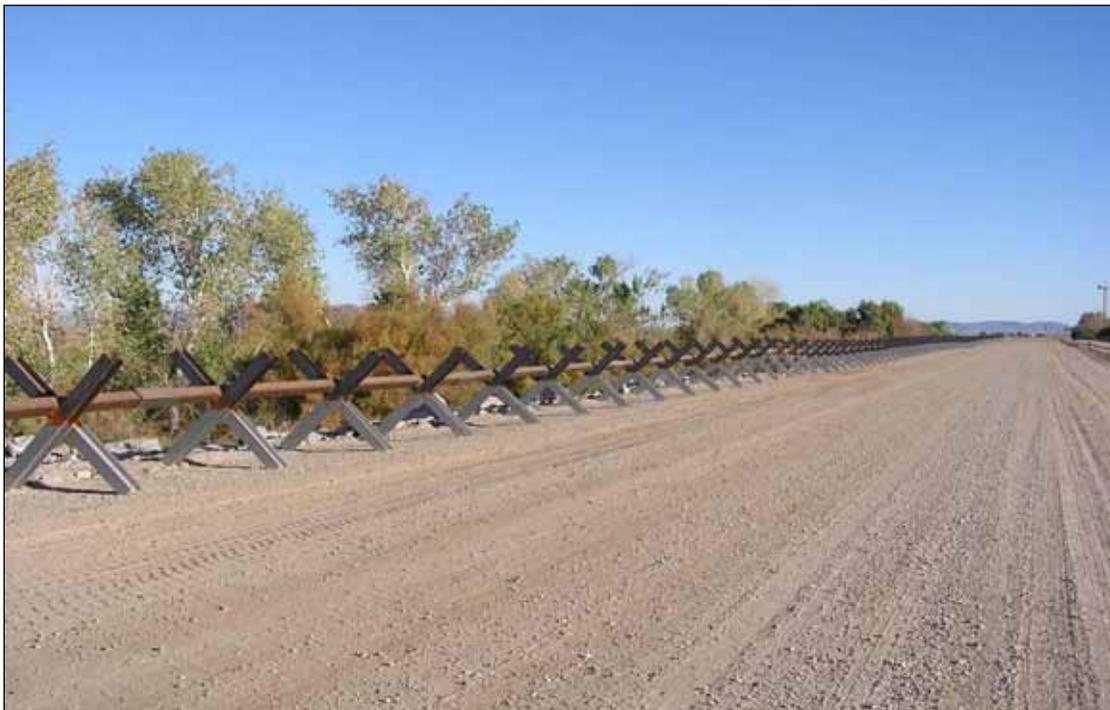
Figure 2-1. Photograph of Completed Normandy-Style Fence, CV-1A

The locations of TI were based on a Yuma Sector assessment of local operational requirements that identified where such infrastructure would assist USBP agents in reducing illicit cross-border activities. Where possible, the location and design of TI was also based on consultation with local stakeholders. The vehicle fence for segments CV-2, CV-2A, and CV-1A consists of a combination of Normandy-style and post-on-rail-style fences (see Figures 2-1 and 2-2).

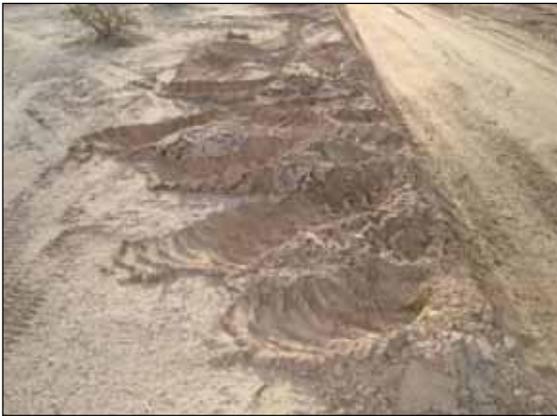
Figure 2-6. Photograph of Off-Road Activity, CV-2

Most BMPs were strictly adhered to during TI construction in the Yuma Sector. The most common BMP infractions included off-road activity (see Figure 2-6), widening of the existing roadbed due to improper use (see Figure 2-7), vertical bollards without temporary or permanent covers (see Figure 2-8), lack of flagging on access roads into and out of the project area (see Figure 2-9), and the lack of drip pans underneath stored equipment (see Figure 2-10). At the close of construction activities, no BMP infractions remained unresolved. One of the highlights of BMP implementation in the Yuma Sector was the low impact on saguaro (*Carnegiea gigantea*) cacti (a forage species for the endangered lesser long-nosed bat [*Leptonycteris curasoae*]) because an access road in CV-2A was not widened and a salvage plan was prepared to help the contractor identify, remove, and transplant the cacti (see Figure 2-3). Of the 276 saguaro cacti in CV-2 and CV-2A, 17 were affected: 13 could not be transplanted and were removed from the project area, three were transplanted outside the project area, and one was flagged for transplant but was accidentally destroyed by construction activities (see Figures 2-11, 2-12, 2-13, and 2-14). Additionally, limiting the width of the project corridor to only what was necessary for construction (approximately 30 feet in most places, rather than the planned 60 feet) and implementing and strictly adhering to BMPs reduced impacts on natural resources, including soil, water, vegetation, and habitat for threatened and endangered species, such as the lesser long-nosed bat (see Figures 2-15, 2-16, 2-17, 2-18, and 2-19).

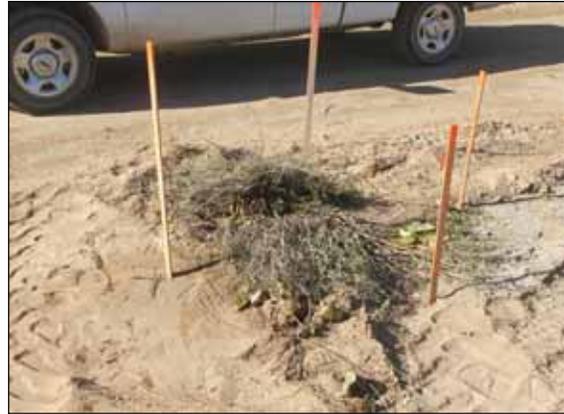
Figure 2-13. Photograph of Destroyed Saguaro, CV-2

One of the highlights of BMP implementation in the Yuma Sector was the low impact on saguaro (*Carnegiea gigantea*) cacti (a forage species for the endangered lesser long-nosed bat [*Leptonycteris curasoae*]) because an access road in segment CV-2A was not widened and a salvage plan was prepared to help the contractor identify, remove, and transplant the cacti. Of the 276 saguaro cacti anticipated to be affected in segments CV-2 and CV-2A, only 17 were affected.

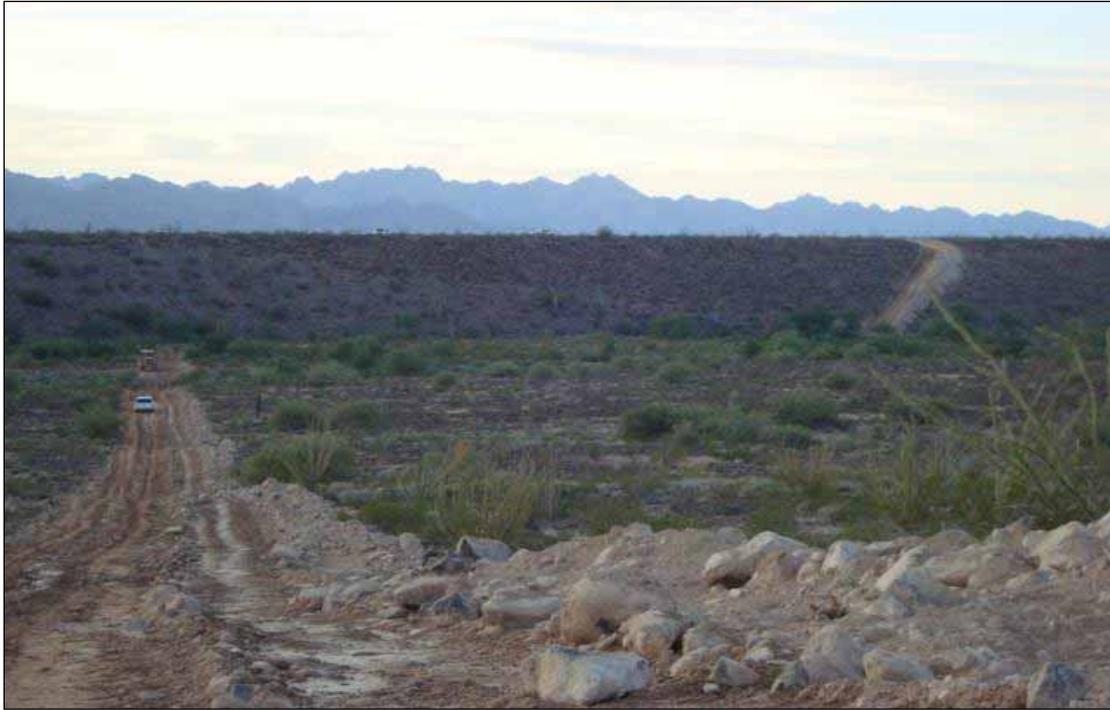
Figure 3-4. Photograph of Access Road, CV-2

Access roads provide access to the border fence and its adjacent construction and maintenance road discussed in Section 3.2. Passing zones can be developed where necessary to allow for safe passage of transport vehicles and equipment. Access roads include passing zones in some places. Temporary road improvements consist of placing aggregate on access roads and passing zones to accommodate large equipment (see Figure 3-4).

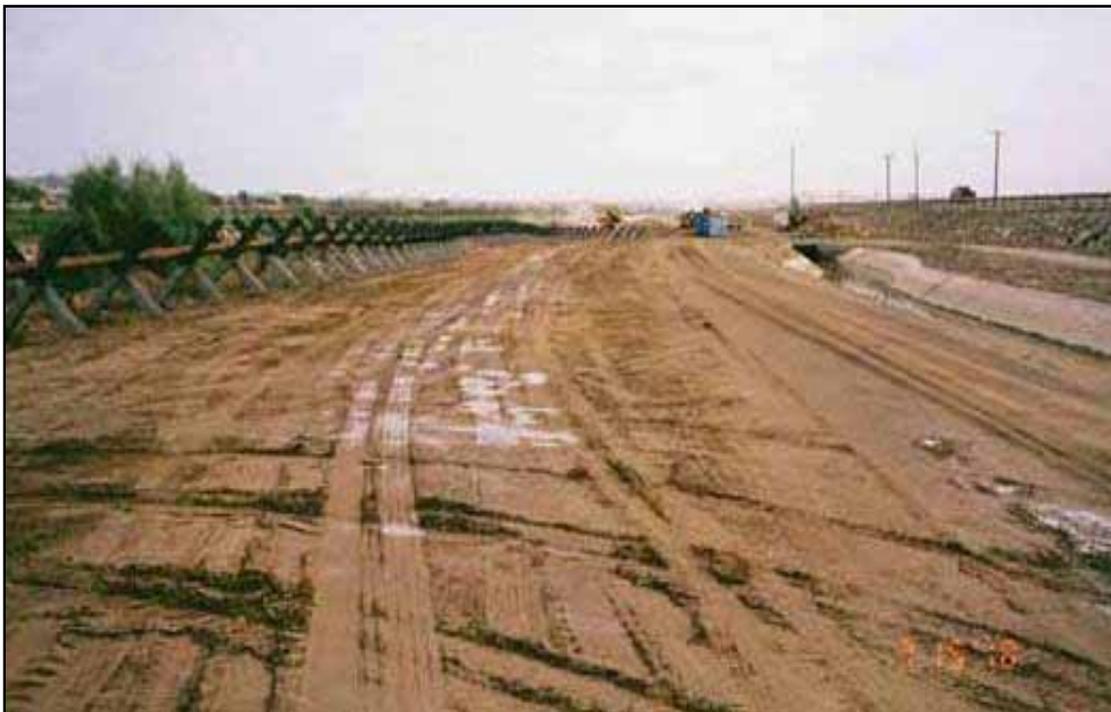
Figure 3-9. Photograph of Segment CV-1A Fence Relocation at Morelos Dam

Segment CV-1A. According to the post-construction survey, the construction footprint of the primary vehicle fence and adjacent construction and maintenance road was almost entirely contained within the 60-foot-wide corridor, which was the planned footprint delineated in the ESP. An exception was the relocation and installation of approximately 1,170 feet of Normandy-style fence adjacent to the Morelos Dam emergency spillway. Construction occurred outside the planned footprint to avoid impeding bypass flows during floods and effectively seal the border (see Figures 3-9 and 3-10).

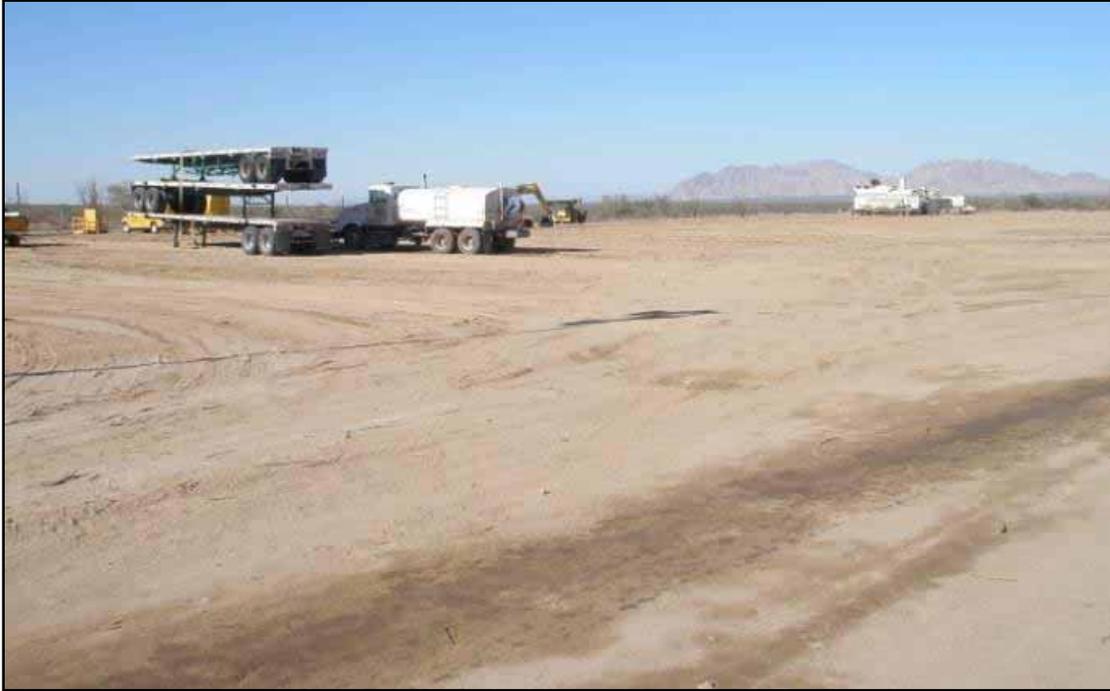
Figure 3-11. Photograph of Staging Area, CV-2

Segment CV-2. The ESP anticipated four staging areas totaling 40.8 acres to facilitate construction of CV-2. The post-construction survey calculated the actual impact area to be 24.1 acres, or 16.7 acres less than anticipated (see Figures 2-3 and 3-11).

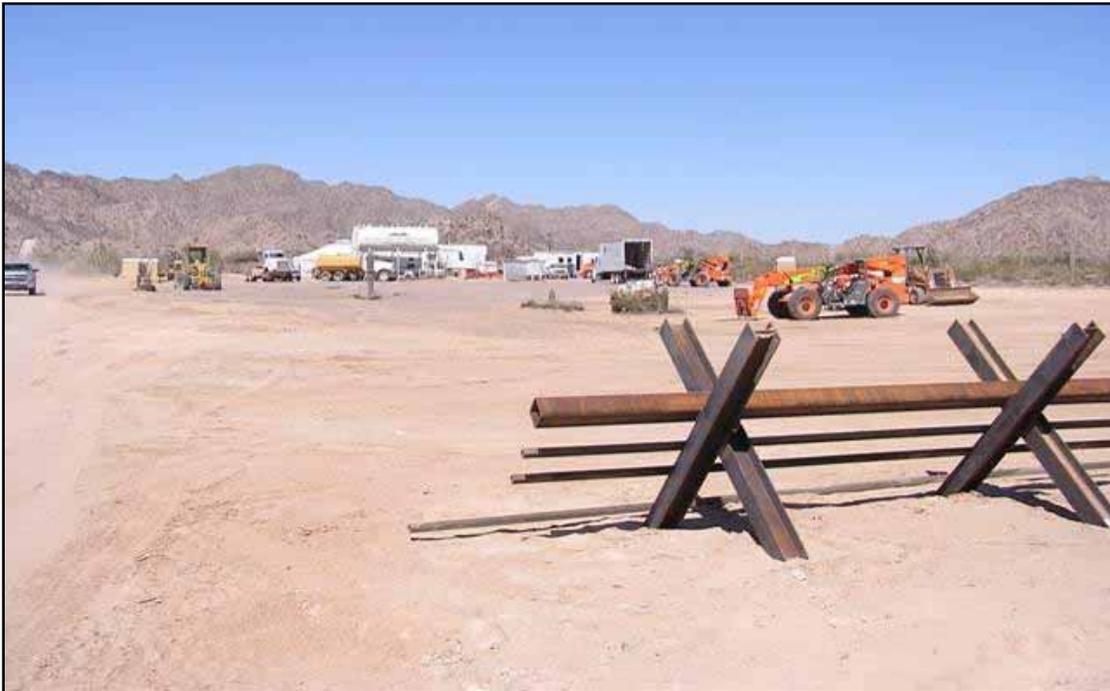
Figure 3-12. Photograph of Staging Area, CV-2A

Segment CV-2A. The ESP anticipated a 0.8-acre staging area just to the north of the mid-point of the fence in CV-2A, adjacent to the access road. The post-construction survey calculated the actual impact area to be 2.7 acres, or 1.9 acres greater than anticipated (see Figures 2-4 and 3-12).

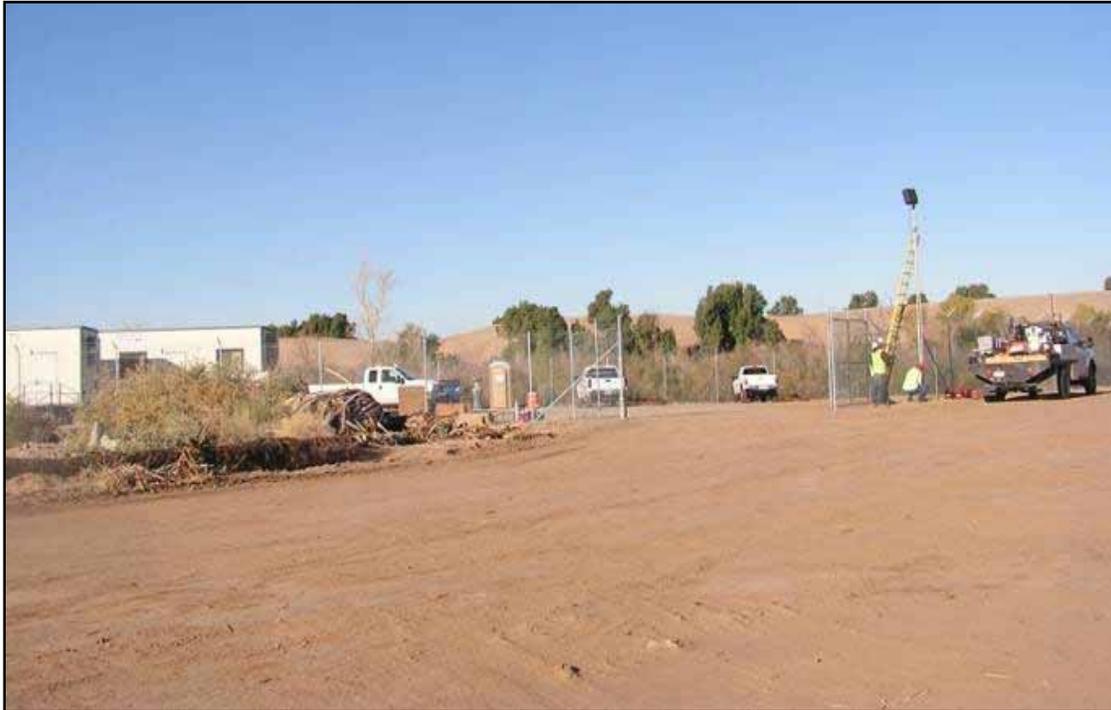
Figure 3-13. Photograph of Staging Area, CV-1A

Segment CV-1A. The ESP anticipated a 0.4-acre staging area for facilitating construction of CV-1A. The staging area was built on previously disturbed lands with no additional impact; therefore, the actual impact area was 0.4 acre less than anticipated. However, a 0.7-acre staging area was required for the Morelos Dam fence relocation, resulting in an overall increase of 0.4 acre over the impact area anticipated for CV-1A (see Figures 2-5 and 3-13).

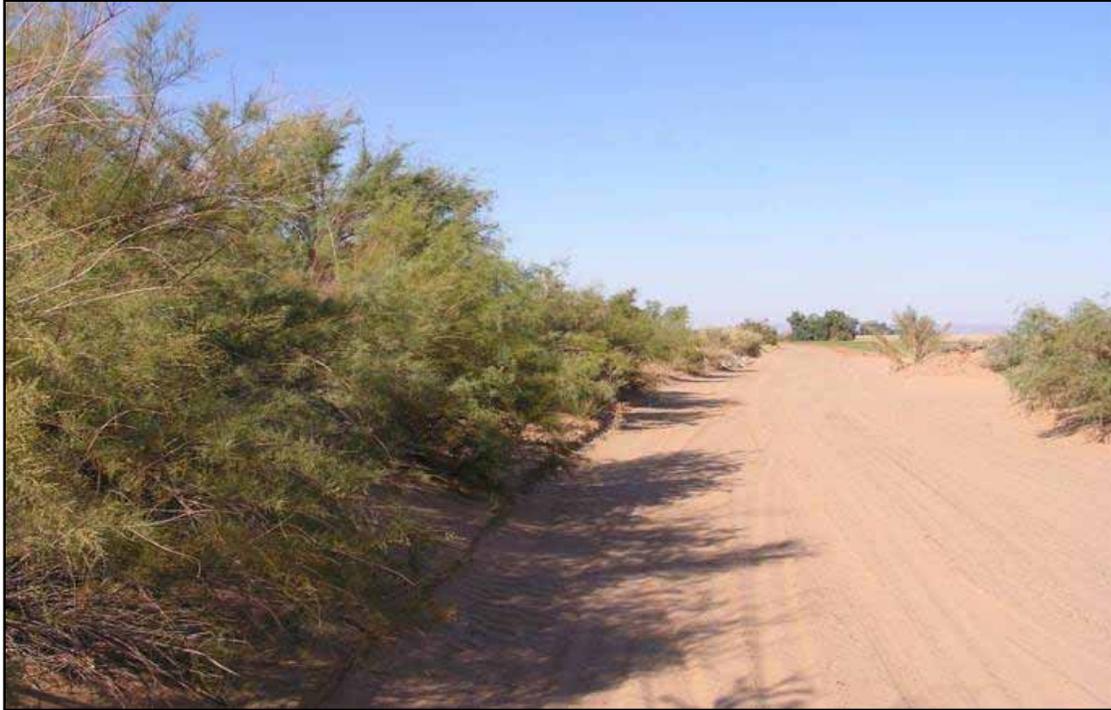
Figure 3-14. Photograph of Vegetative Habitat and Soils, CV-1A

The vegetative habitats within the CV-1A project areas are part of the Sonoran Desert biome (Brown 1994) and consist primarily of creosotebush (*Larrea tridentata*) and bursage (*Ambrosia* spp.) vegetation, and a riparian community immediately adjacent to the Colorado River (see Figure 3-14). Both habitats are typical of the Lower Colorado River Valley subdivision. The creosotebush-bursage community typically is species-poor and consists of a single canopy of low shrubs and sparse herbaceous cover.

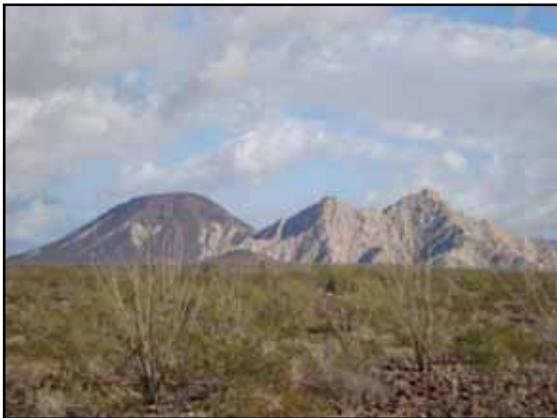
Figure 3-15. Photograph of Vegetative Habitat and Soils, CV-2

The vegetative habitats in CV-2 and CV-2A are consistent with the basin and range lowlands of southwestern Arizona (see Figures 3-15 and 3-16) and have generally been classified under the Dry Domain, Tropical/Subtropical Desert Division by Bailey (1995). The project area is more finely classified by Bailey (1995) as the American Semi-desert and Desert Province, Sonoran Desert Section. There were minimal permanent impacts on vegetation communities within the Yuma Sector.

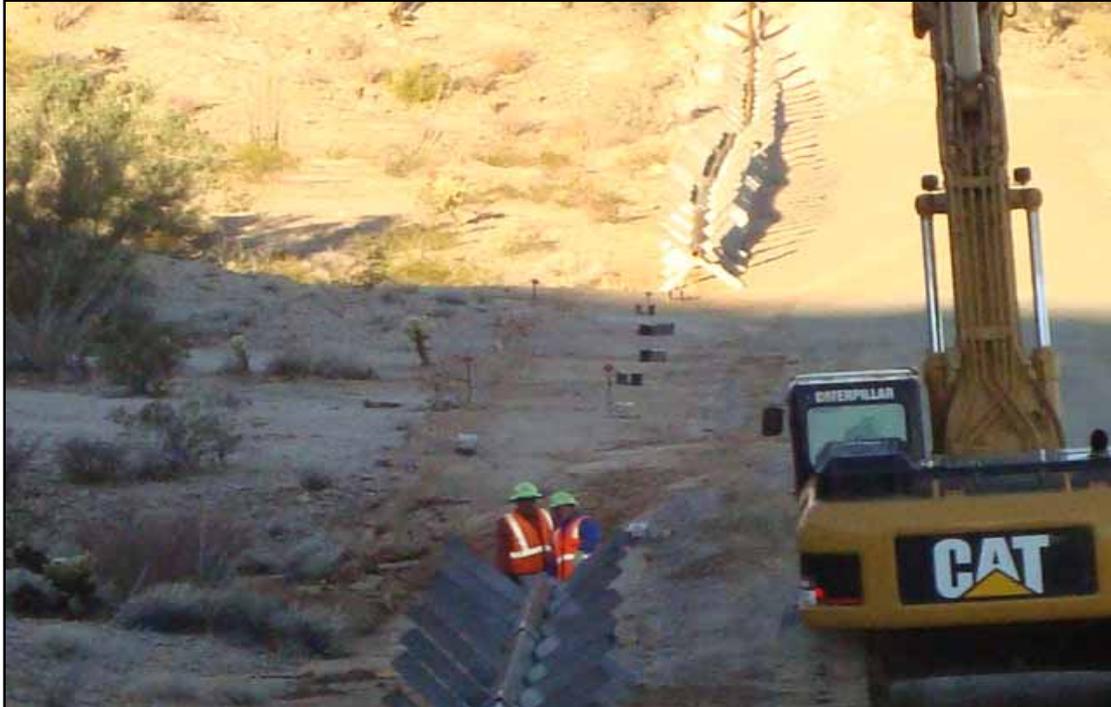
Figure 3-17. Photograph of Washes, CV-2

In segment CV-2, CBP identified 83 wash channels (61.91 acres). Of this area, 17.95 acres were within the project area (see Figure 3-17). No waters of the United States were within the staging areas. Contractors avoided or minimized environmental damage.

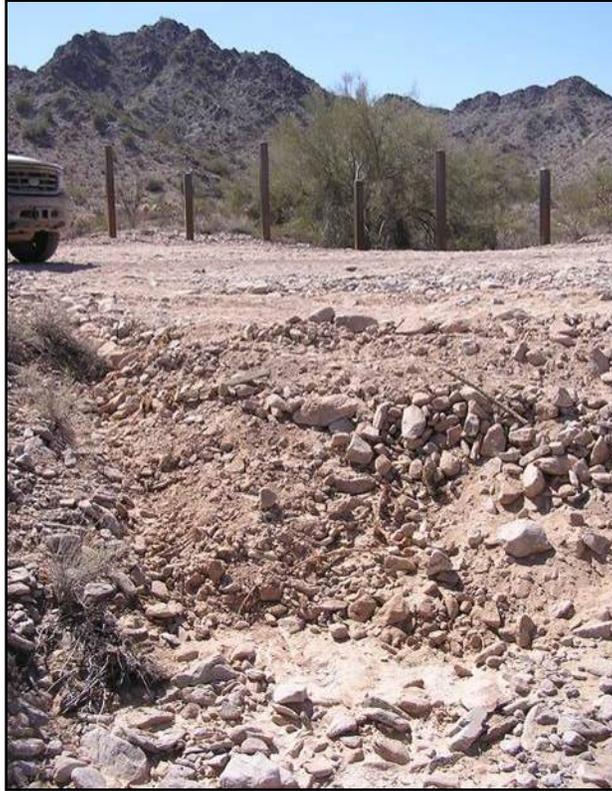
Figure 3-18. Photograph of Washes, CV-2A

For segment CV-2A, CBP delineated all washes and other waters of the United States. They included a total of 27 ephemeral wash channels totaling 1.16 acres. No waters of the United States were within the staging areas. Contractors avoided or minimized environmental damage. A total of 0.78 acre was directly within potential impact areas (see Figure 3-18).

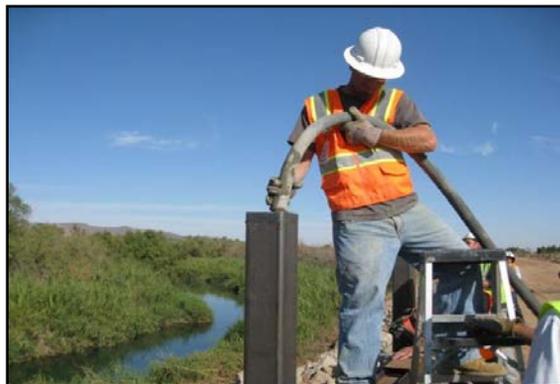
Figure 3-19. Photograph of Wetlands (background), CV-1A

In segment CV-1A, five wetlands were within the project corridor. Wetlands 1 through 4 are in the riparian zone of the Colorado River and total approximately 0.8 acre within the project corridor. Wetland 5 is a small, isolated depressional system that appears to be connected to the Colorado River via a small, shallow overflow system. No waters of the United States were within the staging area. Contractors avoided or minimized environmental damage (see Figure 3-19).
