## A Federal Presence in the Maine Countryside...

### The Limestone, Maine U.S. Inspection Station. Opened 1934.

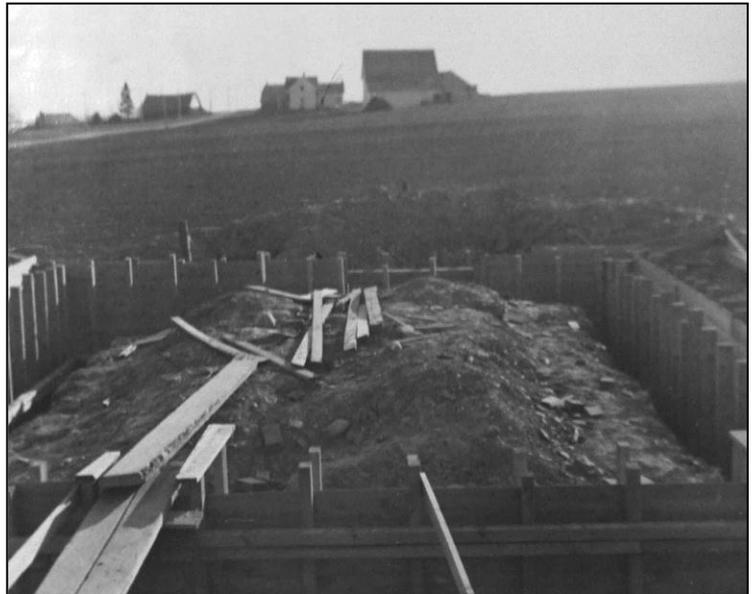
*Top: "U.S. Inspection Station, Limestone, Maine," Drawing of Front Elevation, June 23, 1932.*

*Bottom: Construction photograph with the Phair farm buildings in the background. May 16, 1933*

In August 1932, plans for the "U.S. Inspection Station, Limestone, Maine" were finalized by the Treasury Department's Office of the Supervising Architect, the primary architects for Federal buildings during this time. The final plans were for a complex consisting of an inspection station, two residences, parking areas, driveways, and landscaping, including flagpoles. The facility was located parallel to Grand Falls Road mere feet from the concrete boundary markers at the property line.

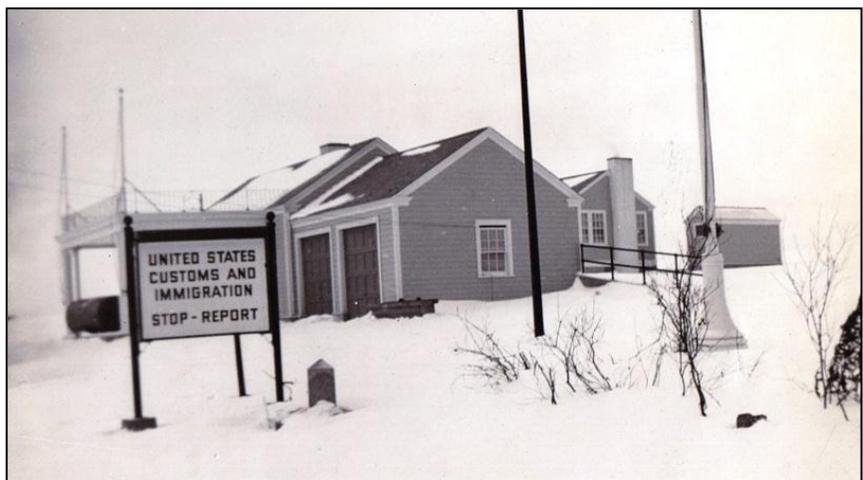
*Completed Limestone, Maine Inspection Station prior to beginning service, December 1, 1933*

At the time of its completion, the Limestone port of entry was a visible reminder of the Federal government and its new border control policies. Typical for the period and Federal government architecture, the facility was designed in the Colonial Revival style. The grounds included a circular concrete driveway that served as the inspection lanes. A gravel driveway was located to the rear of the building and concrete sidewalks circled the perimeter of the building and connected the inspection station to the residences and fueling areas. All of the buildings and structures were all of wood frame construction with painted wood siding.

The inspection station was the primary building of the complex. The multi-light, double-hung wood windows had simple wood surrounds. A single bay vehicle inspection canopy supported by three slender wood columns on the corners projected from the inspection building over the driveway to provide shelter for Customs and Immigration inspections. The building had minimal exterior ornamentation limited to the decorative railing around the top of the canopy.

The inspection station was divided into Customs and Immigration spaces with the two agencies sharing a large public space with a counter and open work areas. The basement contained mechanical and detention areas. The main block of the inspection station was flanked on either side by garages, the one to the west was used for vehicle inspection and the one to the east was used for agency vehicles.

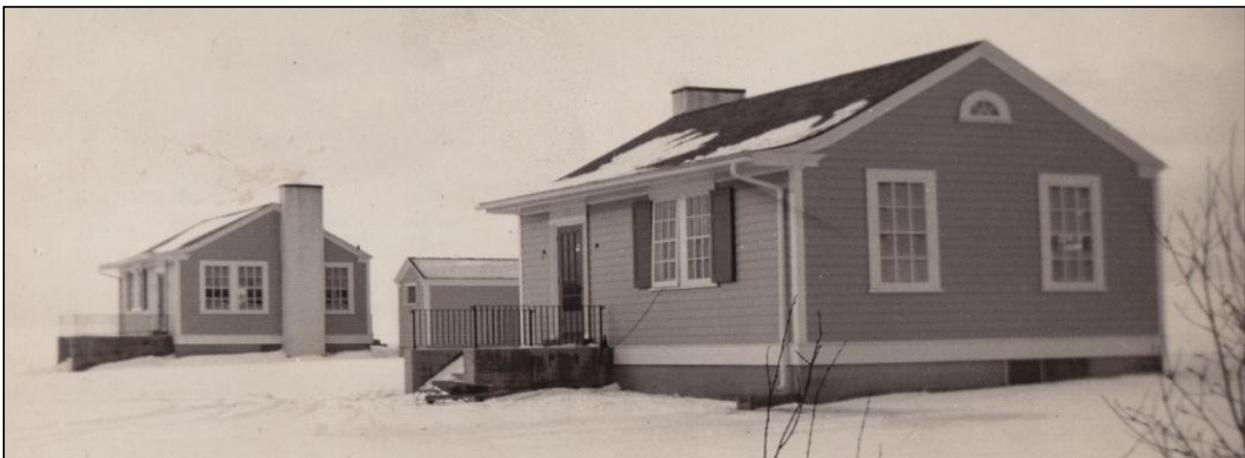
*Completed Limestone, Maine Residences prior to beginning service, December 1, 1933*

To the rear of the inspection station were two residences, one for each of the agencies. The simple 1-story buildings echoed the inspection building in design with multi-light, double-hung wood windows with simple wood surrounds and minimal exterior ornamentation limited to fan lights in one of the gable ends and shutters on the front façade. Each building had a large front porch with a simple metal railing. On the interior, each residence contained a living room with a fireplace, a kitchen, a bathroom and two bedrooms. Adjacent to each residence were small fueling sheds. At an unknown date, the residences and fueling sheds were demolished.
