ACM and LBP Survey Data and Reports

Limited Asbestos Inspection

Project Site: Unit C102 - Single Family Dwelling
Falcon Village, Texas 78545

LCA Project No.: 130602

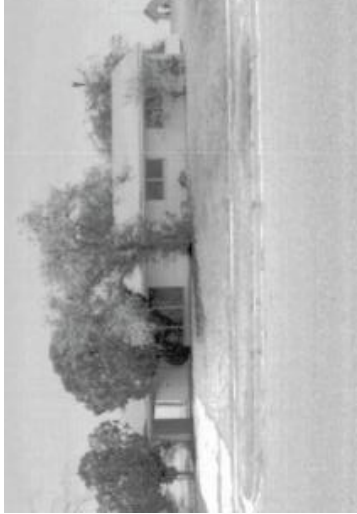
ACM vinyl flooring and black mastic

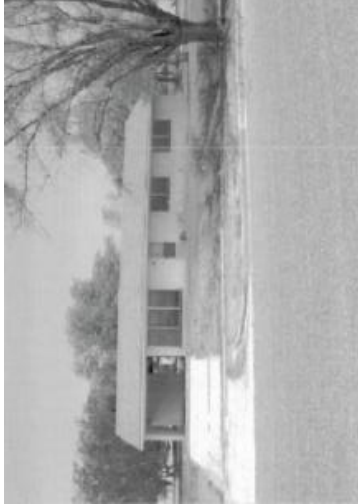
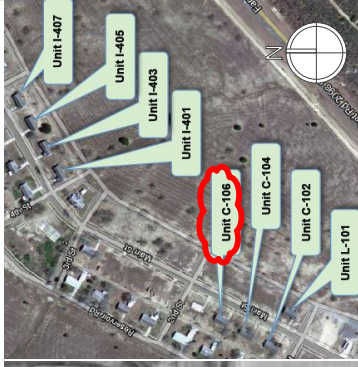
ACM text./joint comp. associated with
gyp-brd walls and ceilings

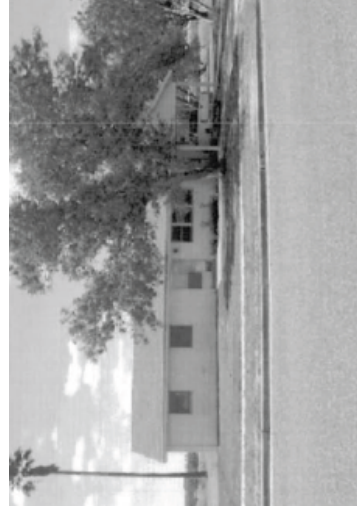
ACM black flooring mastic

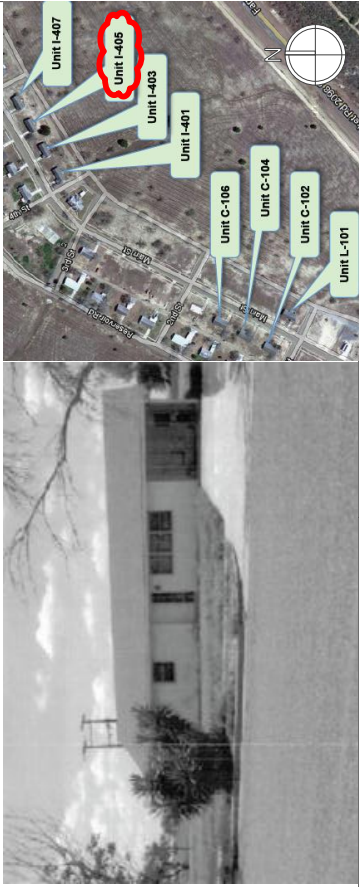
| | | NOT TO SCALE | Quanternary Resource Investigations, LLC NESHAP Compliance Asbestos Survey CBP-Owned Housing, Falcon Village, Texas | Figure 2 Unit 1405 ACBM Location Plan | |

- ACM Exterior Stucco
- ACM vinyl flooring and black mastic
(ACM mastic under ceramic tile in bathrooms)
- ACM text./joint comp. associated with
gyp-brd walls and ceilings

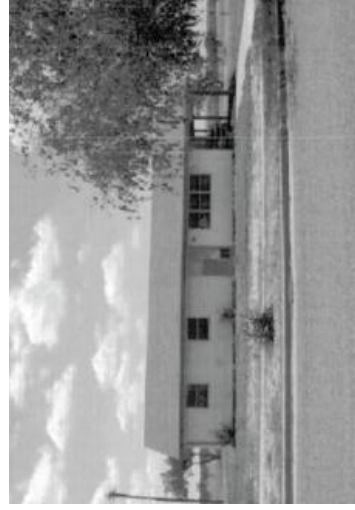
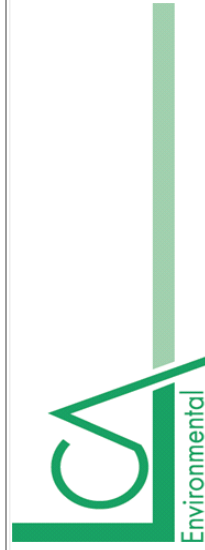
Quanternary Resource Investigations, LLC
NESHAP Compliance Asbestos Survey
CBP-Owned Housing, Falcon Village, Texas

ACM floor tile and black mastic under sheet flooring
(under ceramic tile in bathrooms)

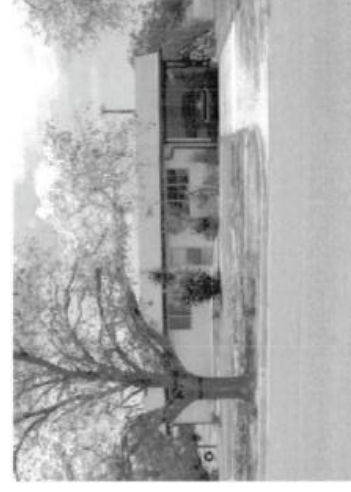
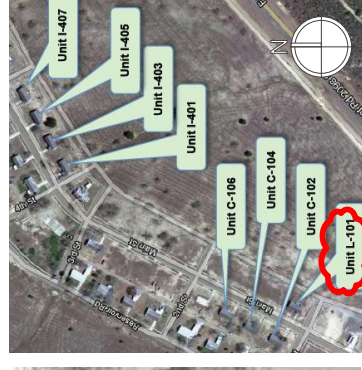
Figure 2
Unit L101
ACBM Location Plan

ACM black flooring mastic

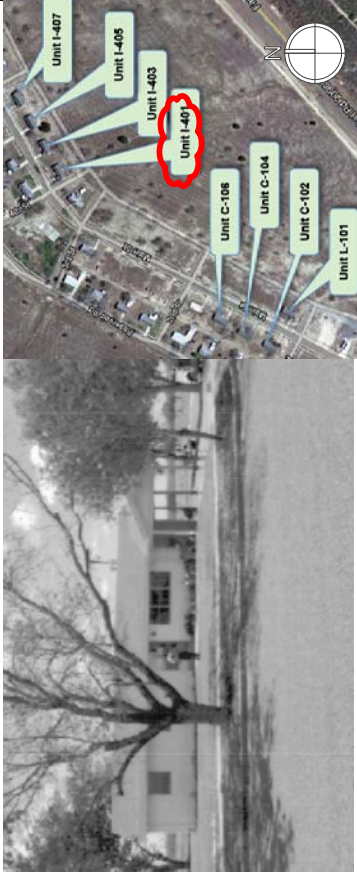
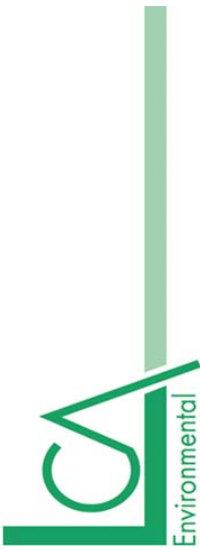
NOTE: No LBP was found during this LBP Inspection.

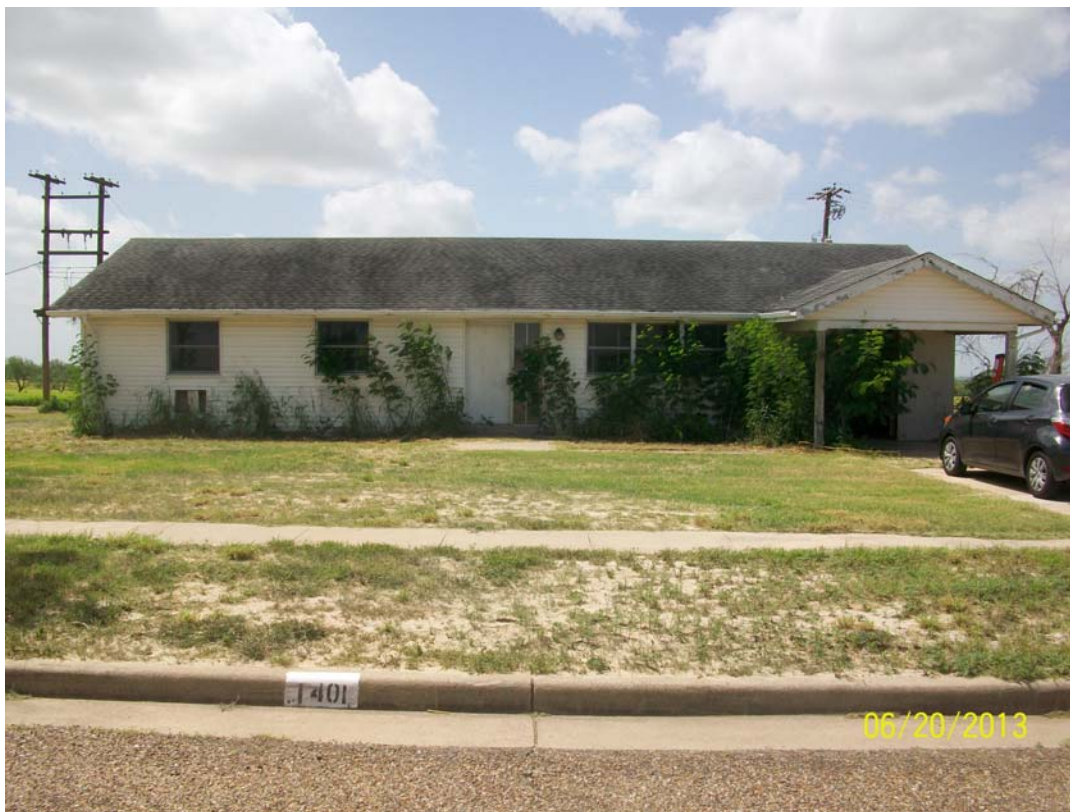
Photograph 1: View of the front of the structure at Unit I401, in Falcon Village, Texas. No LBP was found during this inspection.

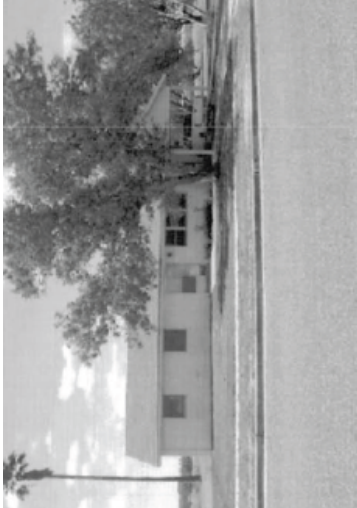
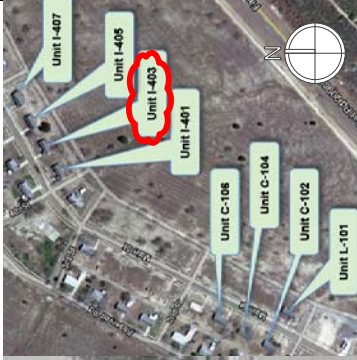
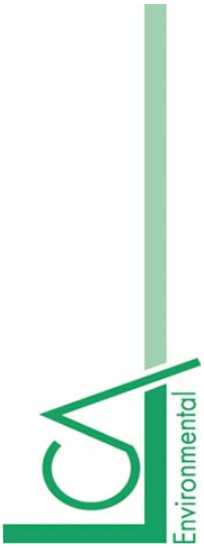
NOTE: No LBP was found during this LBP Inspection.

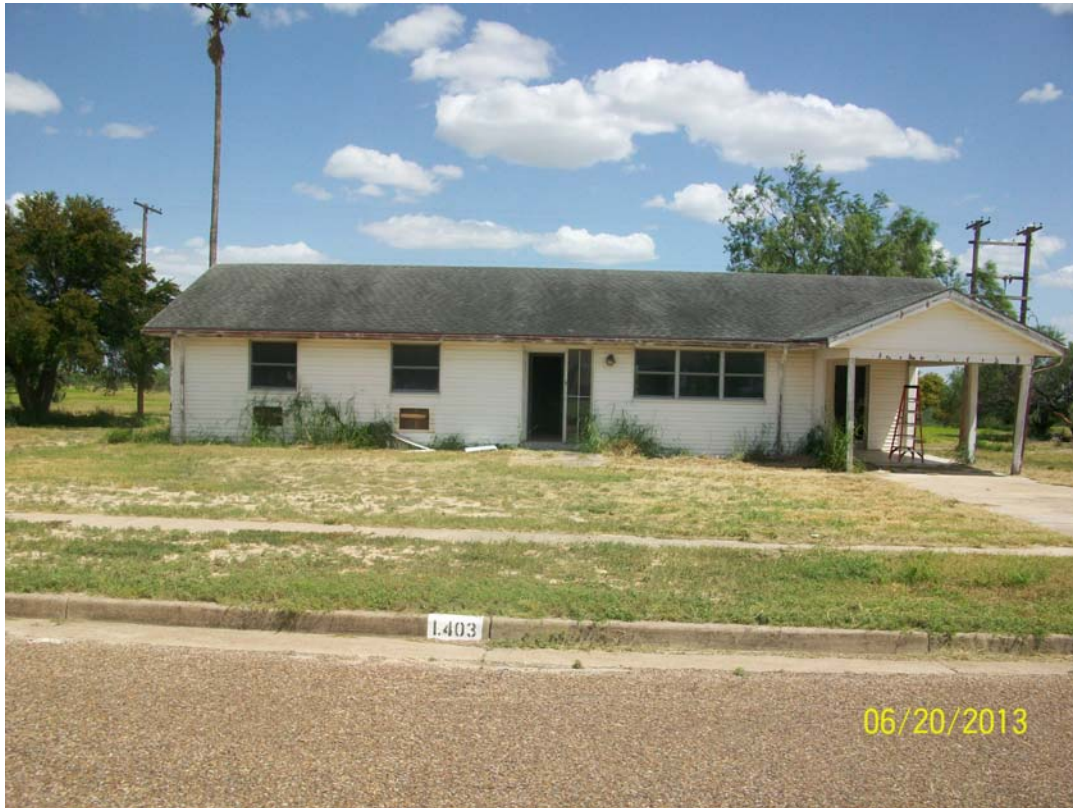
Photograph 1: View of the front of the structure at Unit I403, in Falcon Village, Texas. No LBP was found during this inspection.

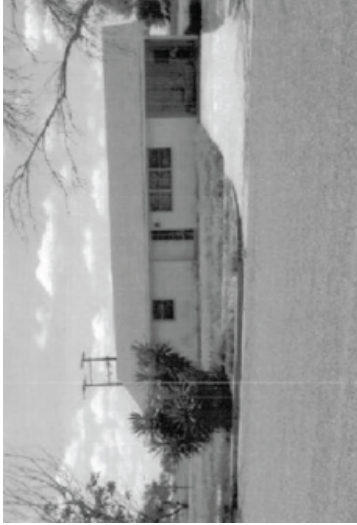
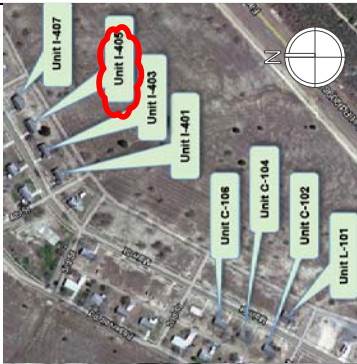
NOTE: No LBP was found during this LBP Inspection.

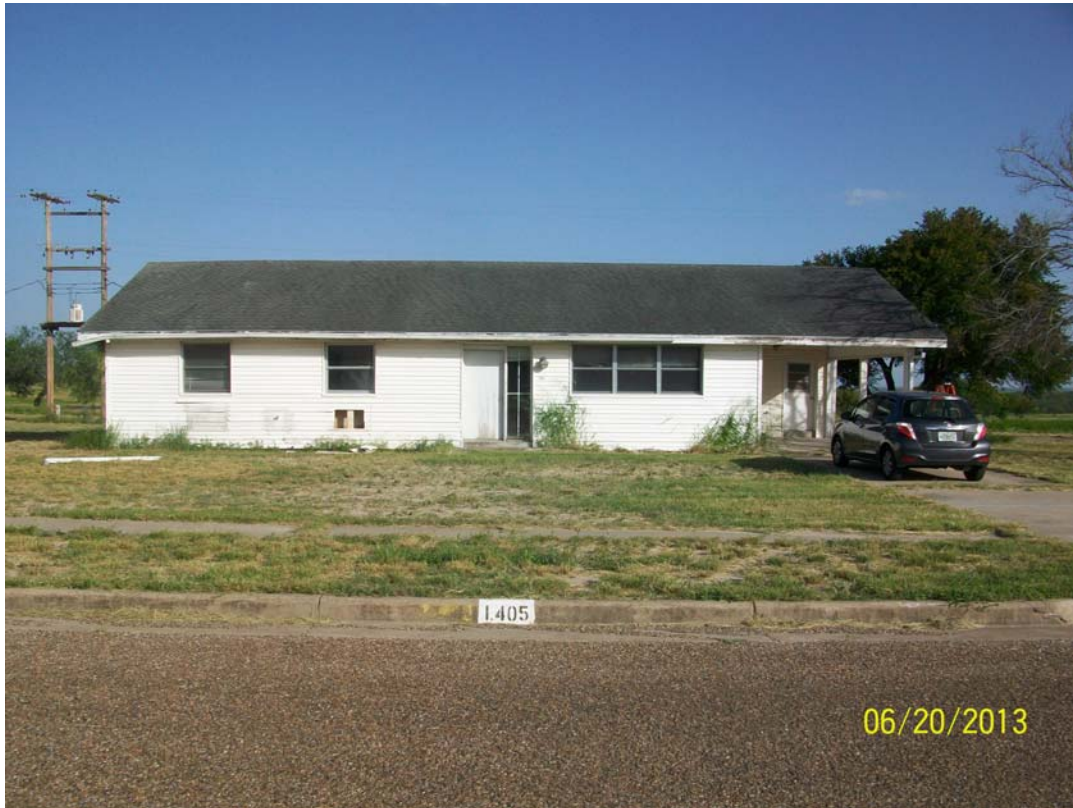
Photograph 1: View of the front of the structure at Unit I405, in Falcon Village, Texas. No LBP was found during this inspection.

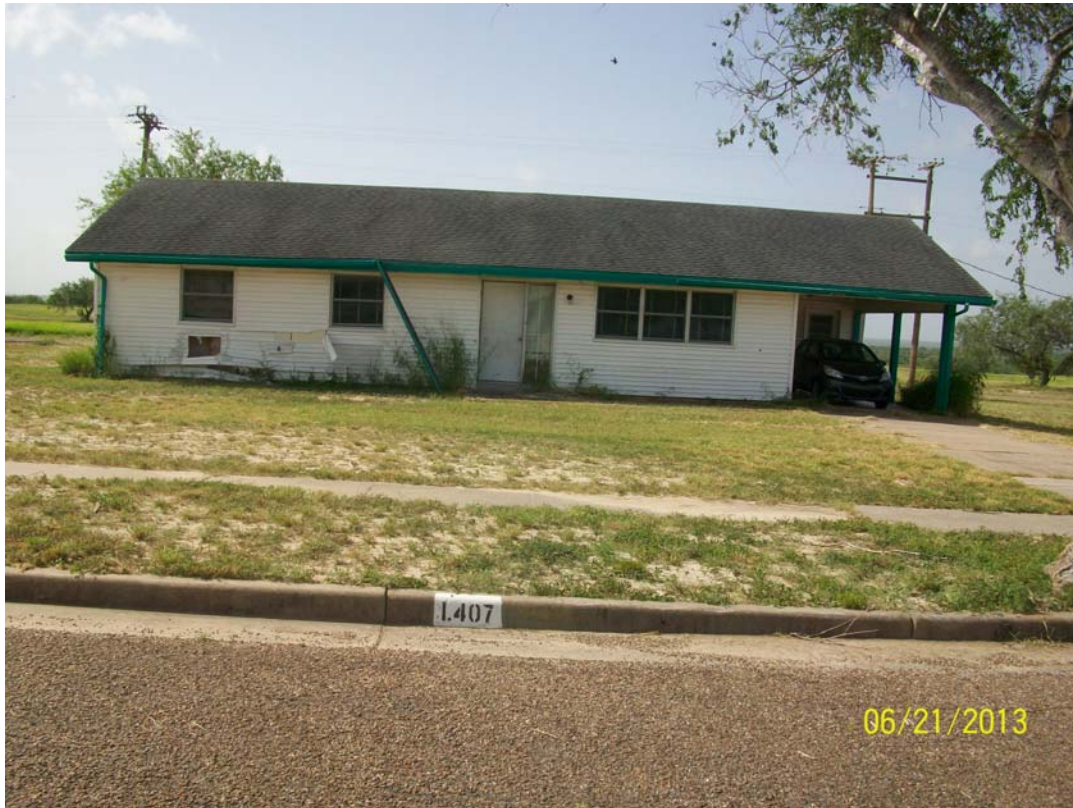
Photograph 1: View of the front of the structure at Unit 1407, in Falcon Village, Texas. No LBP was found during this inspection.
